PROGRESS: 100% - COMPLETED
CZECH REPUBLIC/SEMLEC UND PRČICE/2017-18

RENOVATION OF A HISTORIC BRIDGE

Sedlec-Prčice bridge

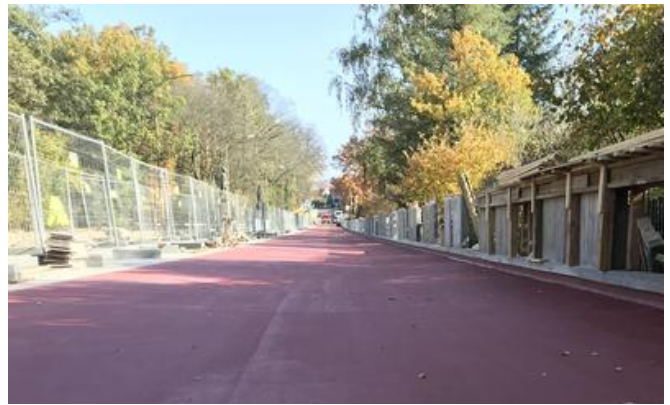
Caption: A new road surface was applied on the bridge and its ageing concrete rails were replaced. Source: PORR

PORR was able to extend its lifespan by replacing the bridge equipment. The road surface and, above all, the ageing reinforced concrete rails were replaced and fully functional bridge draining systems were installed. This work involved installing new parapets, bituminous waterproofing and new composite panels, while the natural stone masonry was also

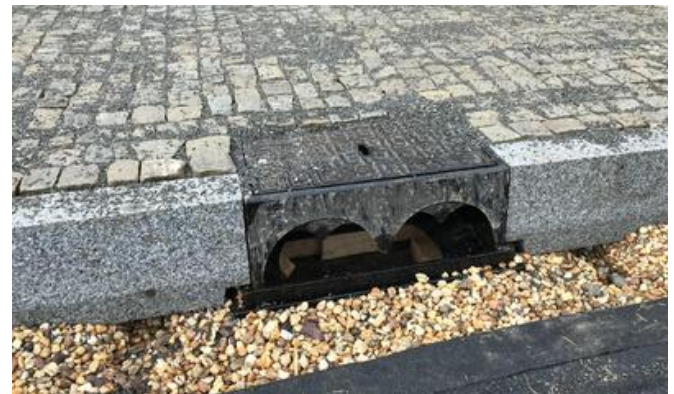
Caption: Even the kerb drainage systems needed to correspond to the specifications set down by the Monument Care Department. Source: PORR

Following installation of the sealing system, kerb drainage points were installed at 10m intervals; like the granite waterspouts, they had to be approved by the Monument Care Department. The same applied to the reinforced concrete rails erected on top of the reinforced covers. A prototype was presented to the Monument Care Department to demonstrate the steel rod interiors. PORR realised a three-layer asphalt carriageway between the kerbs. The pavements feature natural stone paving in a sand bed, with a transverse gradient of 2.5%.

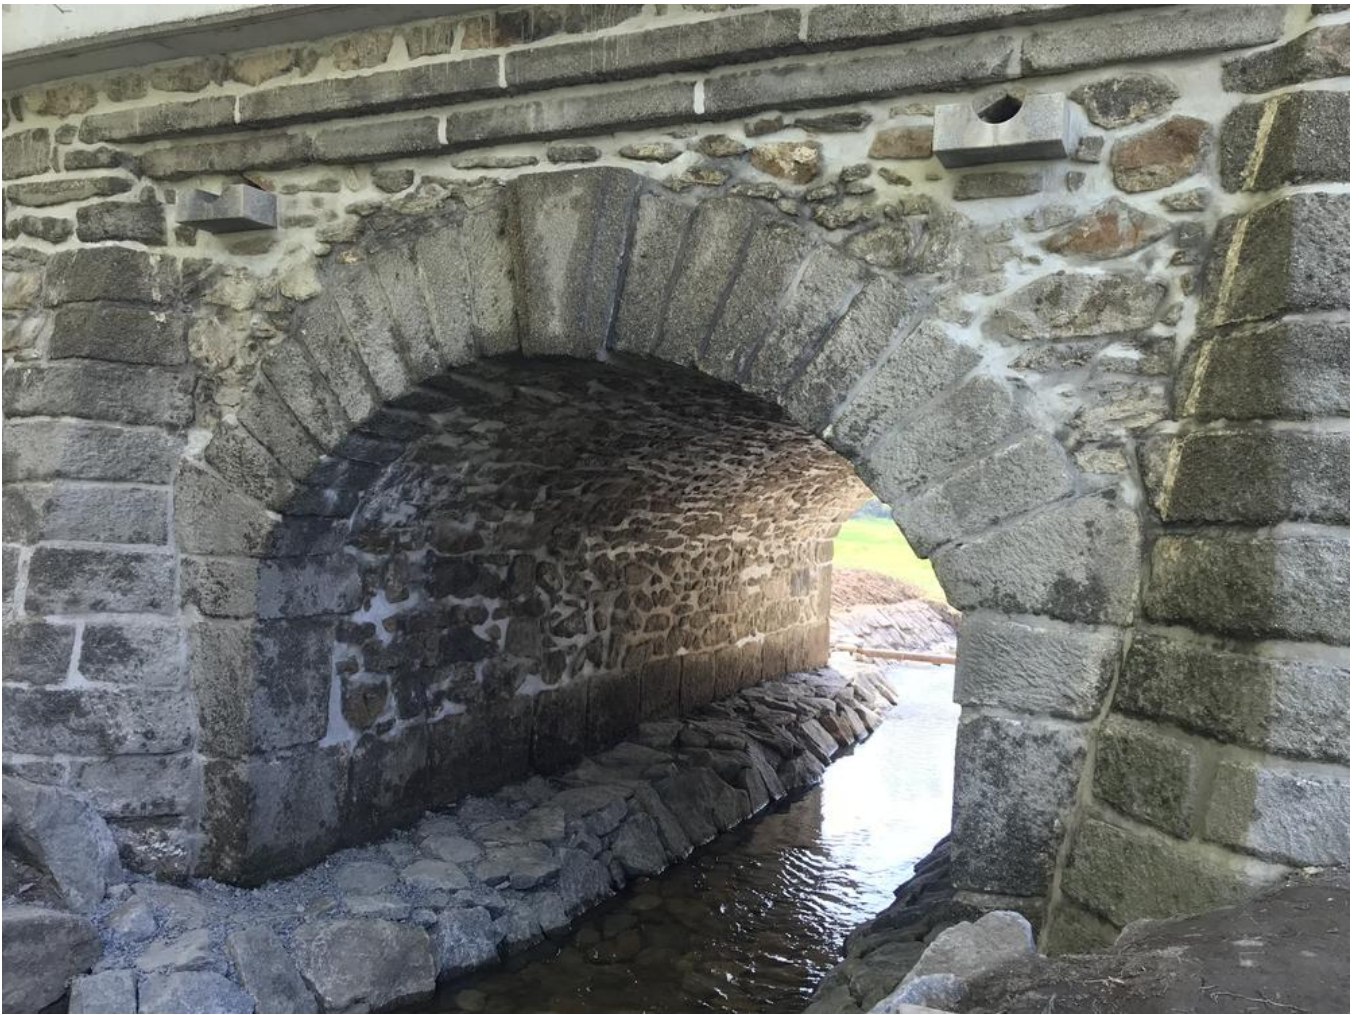
The visible areas of jointing were neither smoothed nor treated in any other way. Missing parts of the natural stone masonry were filled in using rubble. Source: PORR

Once work to install the road surface had been completed and the bridge recommissioned, the arch-supporting scaffolding was dismantled and the arch structures and supporting walls treated with high-pressure water-jet cleaning. The water pressure of 1,200 bar was tested in advance on reference surfaces. In the course of this work and further necessary examinations, cavities were identified in the arches and subsequently filled in using a mortar injection procedure. The natural stone masonry was grouted to a depth of 80mm. The jointing - once again in coordination with specialist heritage officers - was carried out using lime mortar with max. 5% white cement additive for stones made of soft and porous rock and max. 10% for those made of igneous rock. The visible areas of jointing were neither mechanically smoothed nor treated in any other way. Instead, the mortar was coloured with sand to match the natural tone of historic mortar. Any missing or weathered parts of the natural stone masonry were repaired using the resulting rubble, while ensuring the joint distribution remained even.

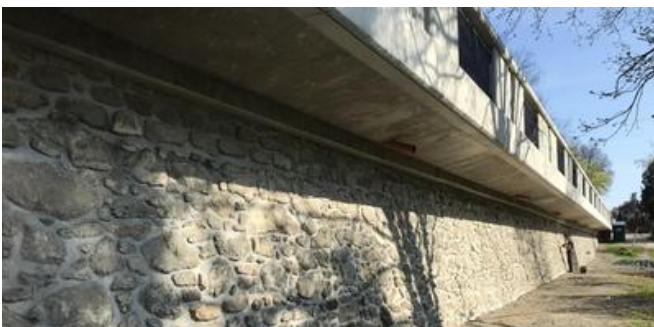
The bridge's foundation is made up of natural stone masonry. Source: PORR

The final part of the restoration work involved replacing the paving on the floodplain and the paving beneath the bridge. The base of the bridge was also consolidated to prevent the parts of the arches that had been filled in and the abutments from being worn away by standard water flows. Some 3m of paving was laid upstream of the bridge as well as 3m downstream and in the entire riverbed beneath the bridge. The entire area covered by the stream during flooding was also cleaned up. Concrete sleepers were used to pave the riverbed.
