PROGRESS: 100% - COMPLETED
AUSTRIA

GENERAL REHABILITATION OF AUSTRIA'S MOST HEAVILY FREQUENTED ROAD

A23 Inzersdorf elevated highway

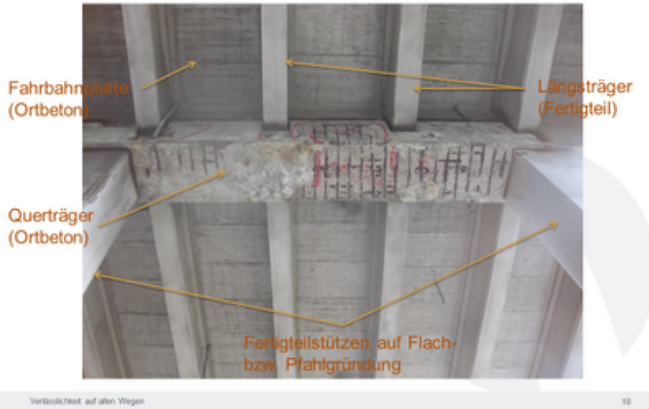
The steep rise in lorry traffic and decades of road salting were the main culprits in inflicting so much damage to the bridge structures that a standard refurbishment would no longer have been economically viable.

Charakteristisches Schadensbild
(Beschichtung am Querträger entfernt)

The steep increase in lorry traffic and prolonged use of road salt have resulted in irreparable damage. Source: PORR

The old elevated highway was therefore completely demolished and rebuilt, and almost 700 metres of the road section were comprehensively rehabilitated. Today, one third of the new Inzersdorf elevated highway runs along an embankment and two thirds along solid, durable bridges.

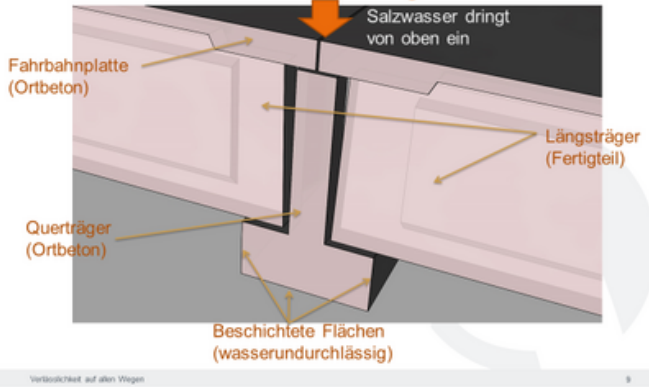
Schadensursache Bestandstragwerke

Depiction of the cause of Damage. Source: PORR
