PROGRESS: 100% - COMPLETED
CZECHIA/SEDEC UND PRČICE/2017-18

RENOVATION OF A HISTORIC BRIDGE

Sedlec-Prčice bridge

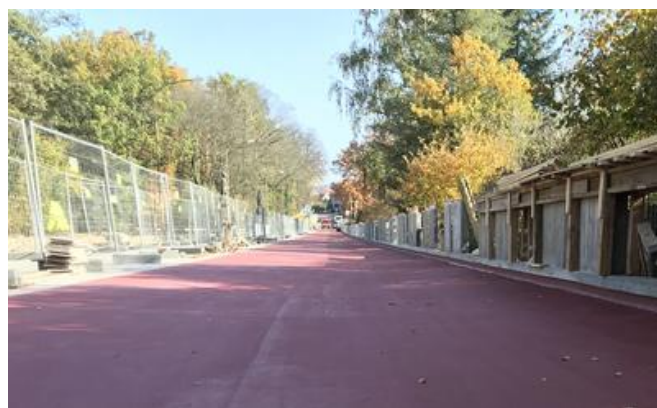
Caption: A new road surface was applied on the bridge and its ageing concrete rails were replaced. Source: PORR

PORR was able to extend its lifespan by replacing the bridge equipment. The road surface and, above all, the ageing reinforced concrete rails were replaced and fully functional bridge draining systems were installed. This work involved installing new parapets, bituminous waterproofing and new composite panels, while the natural stone masonry was also

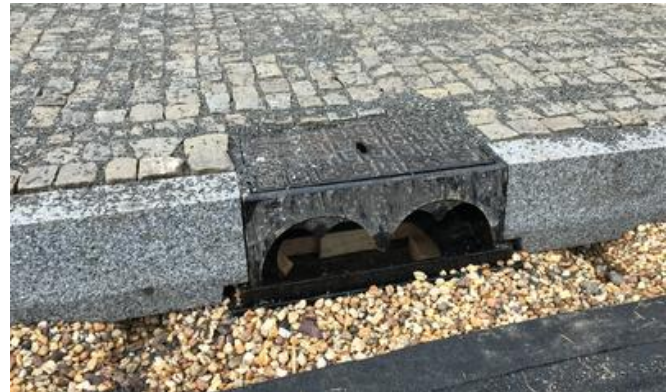
Caption: Even the kerb drainage systems needed to correspond to the specifications set down by the Monument Care Department.
Source: PORR

Following installation of the sealing system, kerb drainage points were installed at 10m intervals; like the granite waterspouts, they had to be approved by the Monument Care Department. The same applied to the reinforced concrete rails erected on top of the reinforced covers. A prototype was presented to the Monument Care Department to demonstrate the steel rod interiors. PORR realised a three-layer asphalt carriageway between the kerbs. The pavements feature natural stone paving in a sand bed, with a transverse gradient of 2.5%.

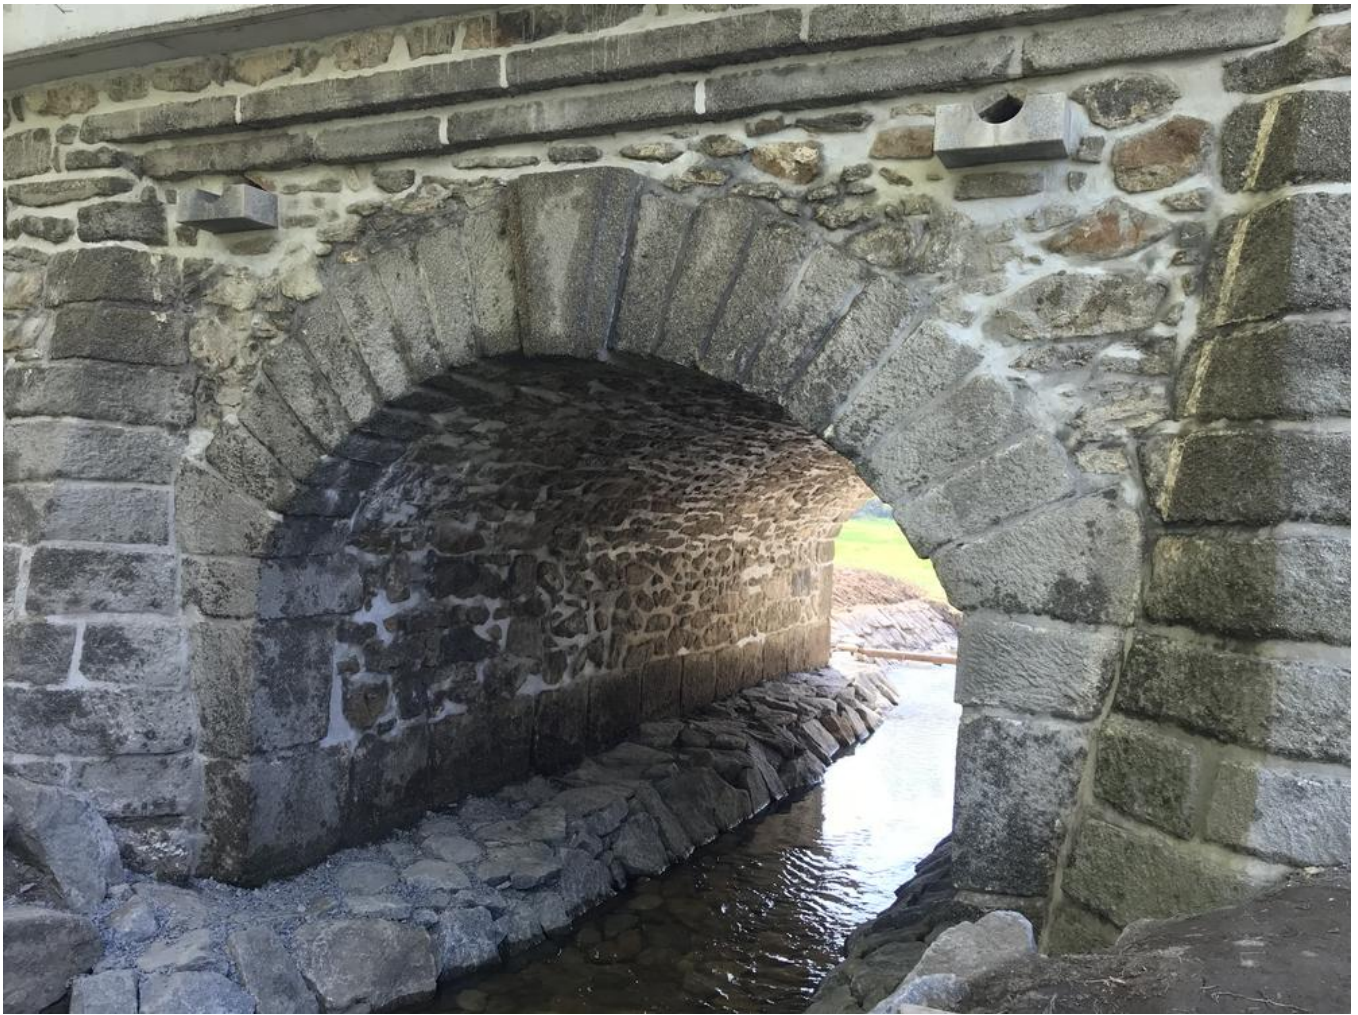
The visible areas of jointing were neither smoothed nor treated in any other way. Missing parts of the natural stone masonry were filled in using rubble. Source: PORR

Once work to install the road surface had been completed and the bridge recommissioned, the arch-supporting scaffolding was dismantled and the arch structures and supporting walls treated with high-pressure water-jet cleaning. The water pressure of 1,200 bar was tested in advance on reference surfaces. In the course of this work and further necessary examinations, cavities were identified in the arches and subsequently filled in using a mortar injection procedure. The natural stone masonry was grouted to a depth of 80mm. The jointing - once again in coordination with specialist heritage officers - was carried out using lime mortar with max. 5% white cement additive for stones made of soft and porous rock and max. 10% for those made of igneous rock. The visible areas of jointing were neither mechanically smoothed nor treated in any other way. Instead, the mortar was coloured with sand to match the natural tone of historic mortar. Any missing or weathered parts of the natural stone masonry were repaired using the resulting rubble, while ensuring the joint distribution remained even.

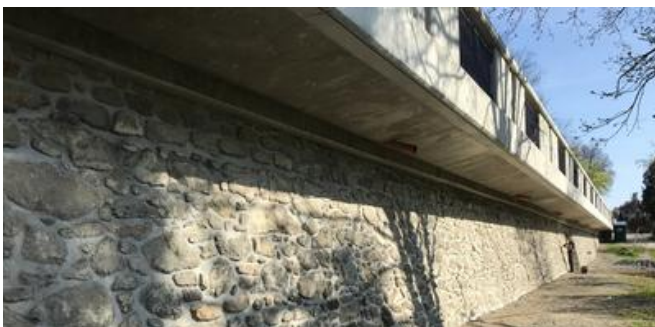
The bridge's foundation is made up of natural stone masonry. Source: PORR

The final part of the restoration work involved replacing the paving on the floodplain and the paving beneath the bridge. The base of the bridge was also consolidated to prevent the parts of the arches that had been filled in and the abutments from being worn away by standard water flows. Some 3m of paving was laid upstream of the bridge as well as 3m downstream and in the entire riverbed beneath the bridge. The entire area covered by the stream during flooding was also cleaned up. Concrete sleepers were used to pave the riverbed.
