GENERAL REHABILITATION OF AUSTRIA'S MOST HEAVILY FREQUENTED ROAD

A23 Inzersdorf elevated highway

Author: Franz Hrebik

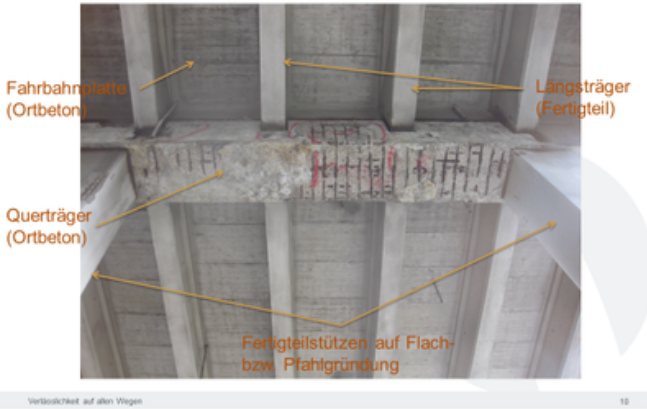
The steep rise in lorry traffic and decades of road salting were the main culprits in inflicting so much damage to the bridge structures that a standard refurbishment would no longer have been economically viable.

Charakteristisches Schadensbild
(Beschichtung am Querträger entfernt)

The steep increase in lorry traffic and prolonged use of road salt have resulted in irreparable damage. Source: PORR

The old elevated highway was therefore completely demolished and rebuilt, and almost 700 metres of the road section were comprehensively rehabilitated. Today, one third of the new Inzersdorf elevated highway runs along an embankment and two thirds along solid, durable bridges.

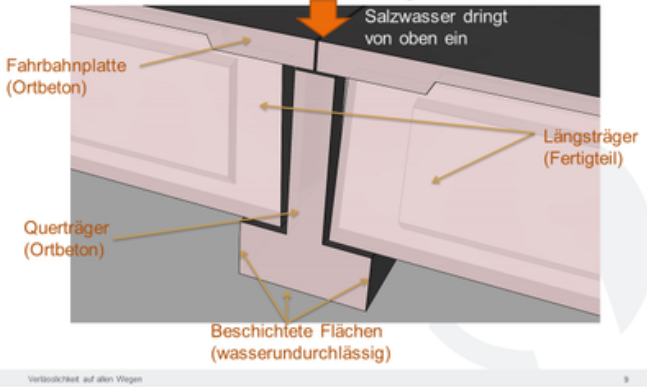
Schadensursache Bestandstragwerke

Depiction of the cause of Damage. Source: PORR
