## REHABILITATION OF THE ARLBERG RAILWAY'S HIGHEST VIADUCT

### Schmiedtobel viaduct

**PORR rehabilitated the Arlberg railway's 130-year-old Schmiedtobel viaduct under extreme time pressure and highly cramped conditions.**

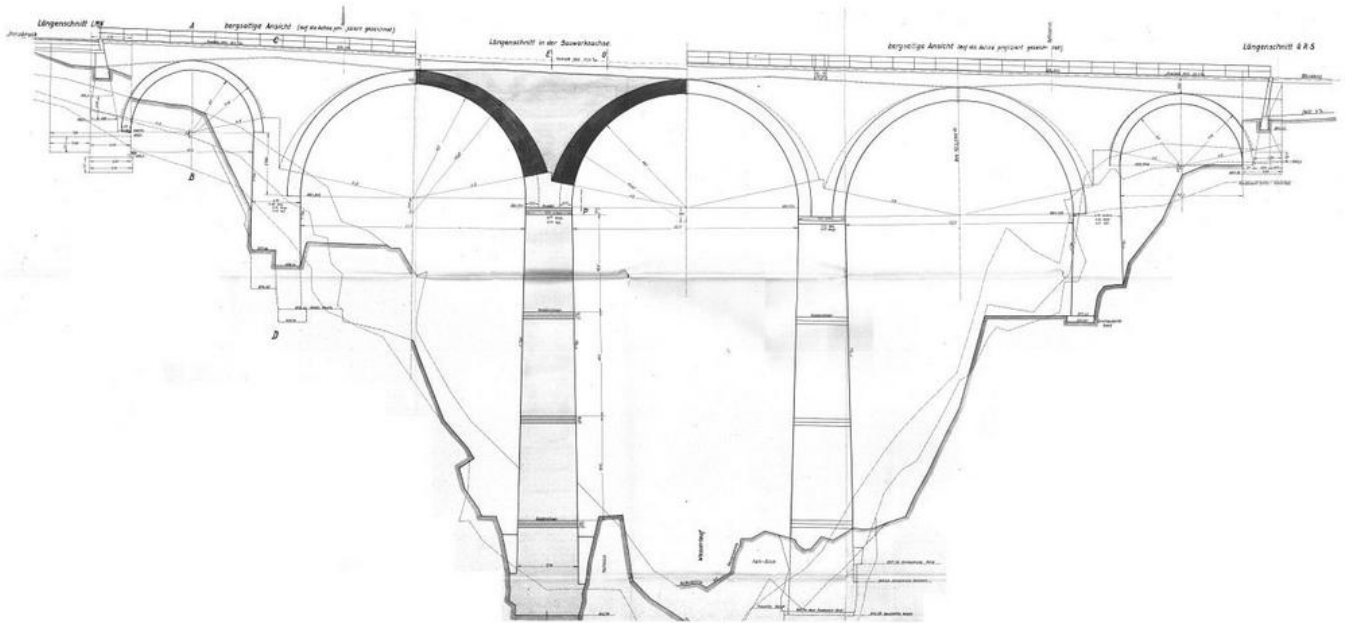
As-built drawing of the “Viaduct across the Schmied-Tobel” built in 1883 Source: ÖBB

The viaduct consists of three larger arches with a 26.6m span in the middle and two smaller arches on either side, in front of the abutments. The approximately 4.5-metre-wide vaulted arches have been bricked up with roughly 80cm-thick side walls. Previously, the gap had been filled with bulk material and, in some places, tamped concrete. A drainage level runs through the roof profiles along the viaduct. The water is drained from the lowest point at the centre of each arch.

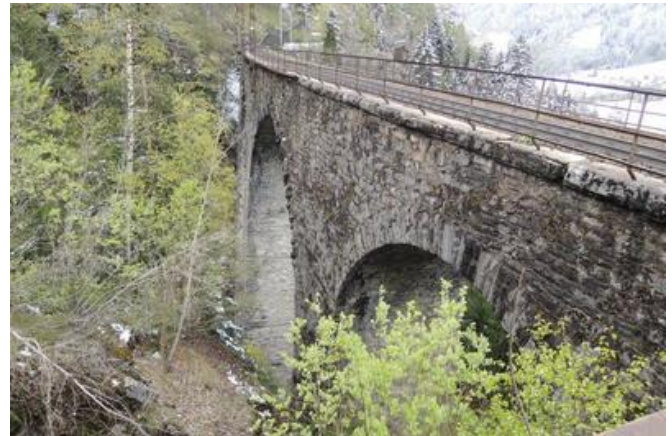
The Schmiedtobel viaduct before the start of construction Source: PORR

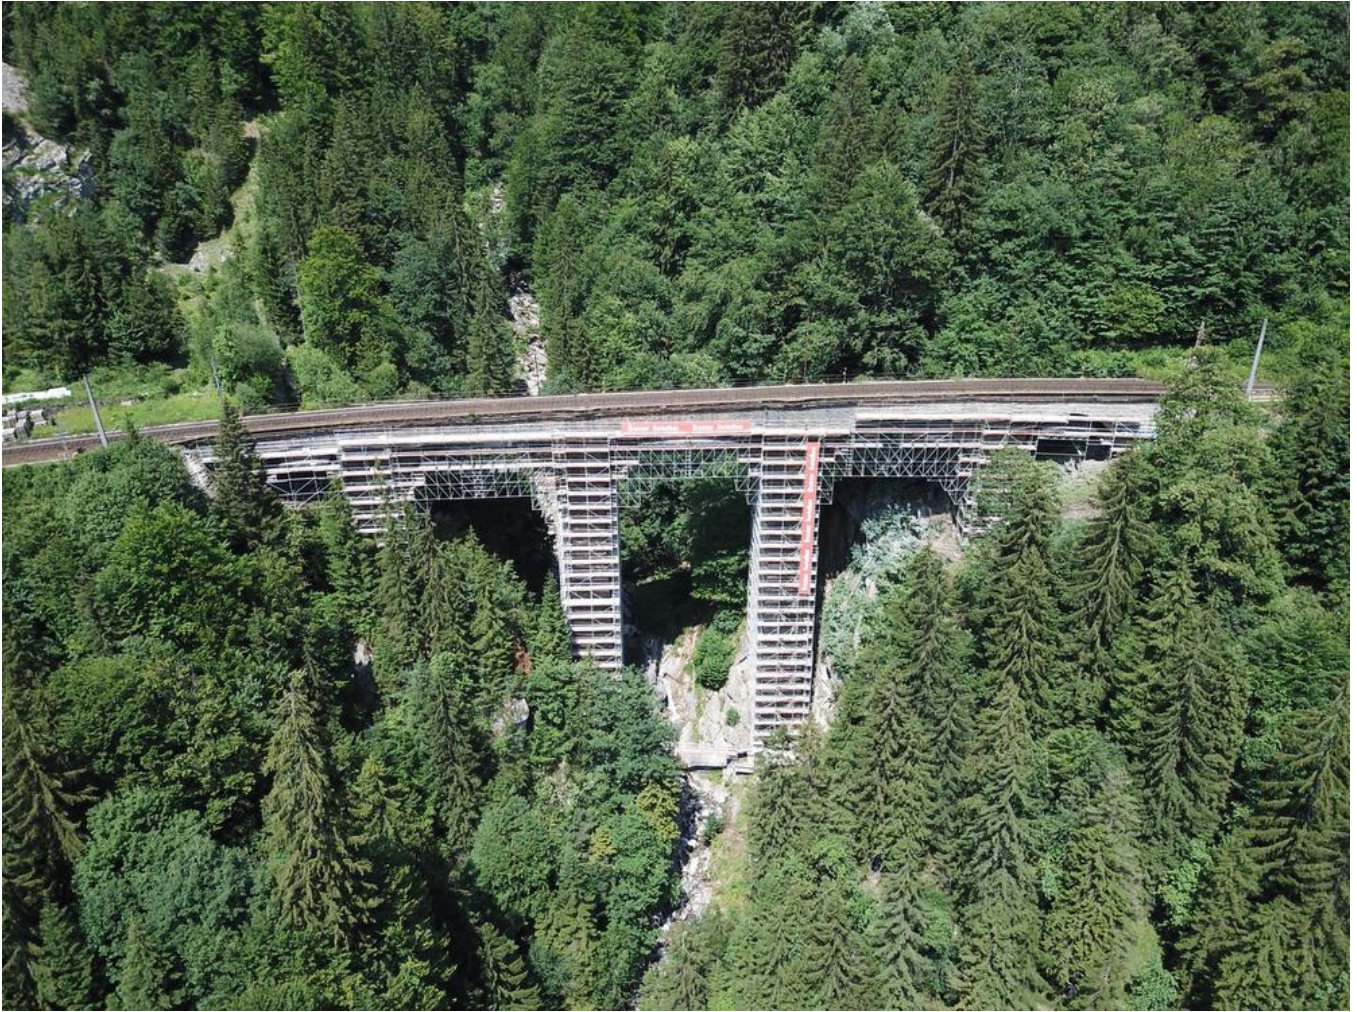
A total of 320t of material was used for scaffolding the Schmiedtobel viaduct. Source: PORR

For reasons of construction logistics, the prefabricated edge-beam parts were produced as early as March 2018, transported by rail during a short interim track closure period, and stored on the west side of the viaduct prior to installation. As the renovation work on the vault and viaduct masonry could not be carried out within the track closure period, scaffolding was erected around the entire bridge structure from June to July 2018. The extremely steep terrain leading up to the pier bases presented a major challenge for the scaffolders. A supply ropeway was slung across the ravine to transport the scaffolding material, which weighed 320t. A bracket scaffold with a railing was also attached to the existing wall at track level that would subsequently serve as a demolition, work and protection platform.

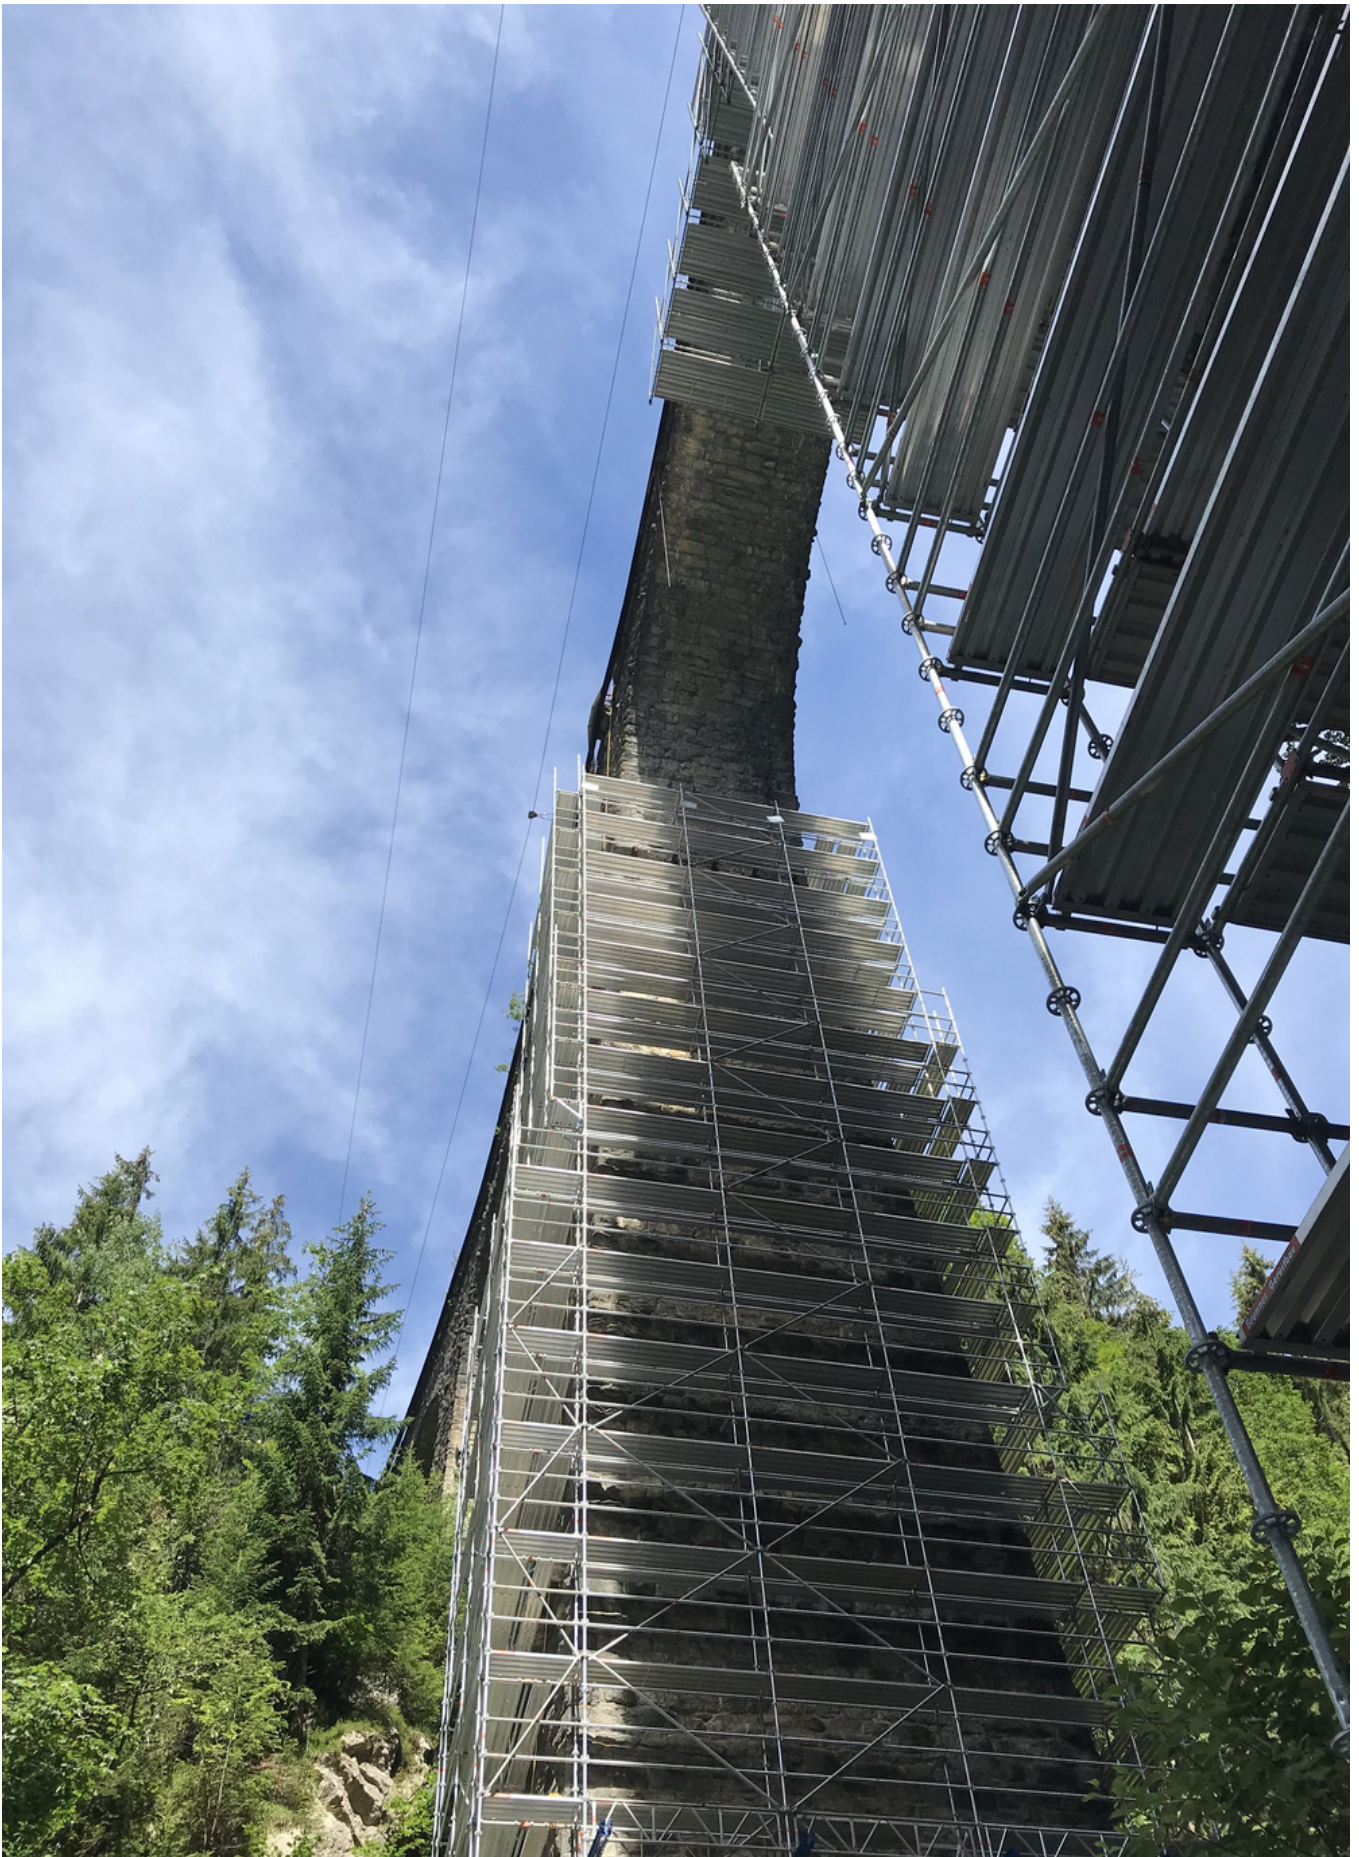
Using a rope crane to scaffold the pier. Source: PORR

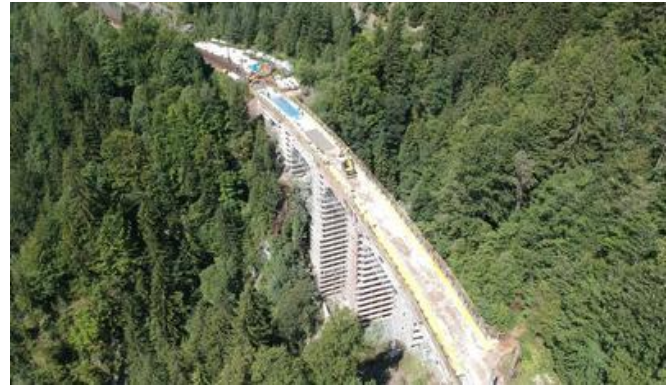
The entire frame had to be rehabilitated within a two-week track closure period in August. Source: PORR

After ÖBB had completed preliminary works, including removing the overhead line and dismantling the track grid, PORR was able to begin renovating the supporting frame. The first step involved cutting the vault walls horizontally to align with the bottom level of the new frame. This was followed by removing the railing including the cable duct, clearing the track ballast, and dismantling the side walls and the vault filling.

The entire frame had to be rehabilitated within a two-week track closure period in August. The extremely tight construction schedule was planned down to the hour and presented enormous logistical and technical challenges for PORR’s site employees. Nevertheless, the Arlberg railway was reopened to traffic on 3 September 2018 as planned.
