# NEW LANDMARK IN THE HEART OF THE NORWEGIAN FJORDS

## The Loftesnes Bridge

With the construction of the Loftesnes Bridge, which won a European Steel Bridge Award, the PORR subsidiary PNC has realised an important project in Norway.

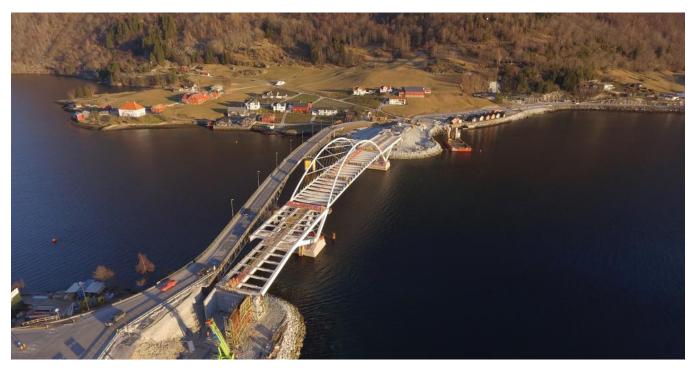
The old bridge was in use until the new bridge had been completed. Source: PNC Norge AS

The new bridge was constructed in just under two and a half years, directly alongside the old Loftesnes Bridge, which had to be kept open to traffic until completion. The spatial proximity of the two structures combined with difficult ground conditions made constructing the bridge's foundations a real challenge. Ground movements and earth tremors had to be closely monitored in order to avoid negative effects on the old bridge while 28 tubular steel piles were driven into the fjord bed to serve as supports for the main foundations.
