RETREADED TRAM INTERSECTION IN FLORIDSORF

Track and master builder work “Am Spitz”

During a three-month construction period, PORR renovated the tram tracks around the “Am Spitz/Brünner Strasse/Prager Strasse/Schlosshofer Strasse” intersection.

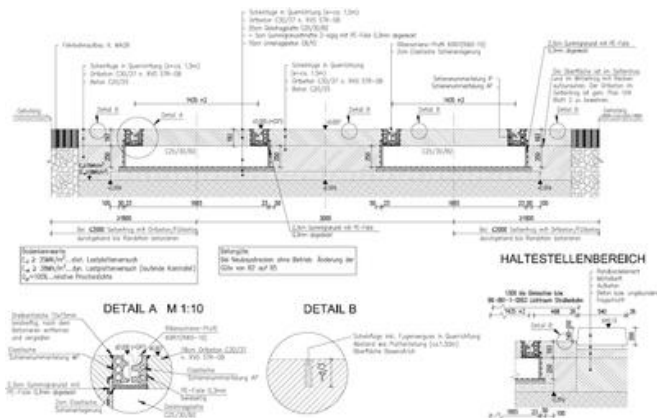
PORR installed sound-insulating and soundproof superstructures to protect the local residents. Source: Wiener Linien GmbH & Co KG

Due to the densely populated area around the project, at the planning stage the client specified two superstructures for sound insulation and soundproofing. The sound-insulating superstructure was created by laying the jacketed rails on an unreinforced track slab. The soundproof superstructure consisted of a lightweight mass-spring system with 25cm forces. The track slab was strengthened with a reinforcement cage and elastic rubber mats were used to create a separation from the filling concrete either side and from the granular subbase below; this reduces vibrations from the tramway.

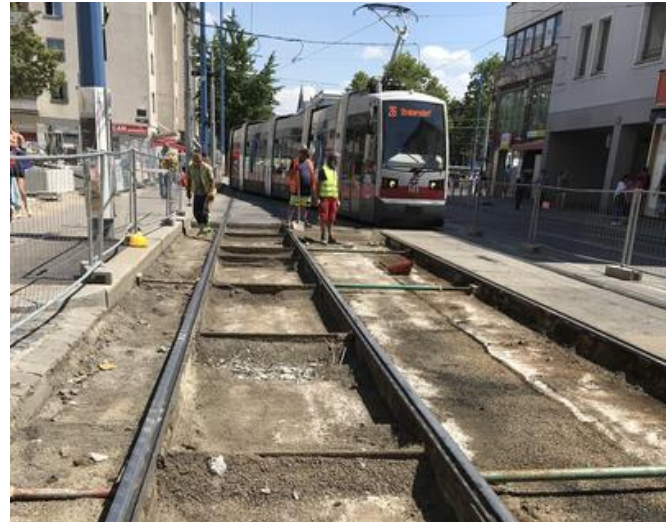
The pre-fabricated concrete slabs and the gravel bed were professionally dismantled. Source: PORR AG

During the first part of the work, the existing surface, consisting of pre-fabricated concrete slabs between the rails, was removed.

In the curve, the concrete track slab was demolished by an excavator with a hydraulic hammer – as it was reinforced, this was a very time-consuming process.

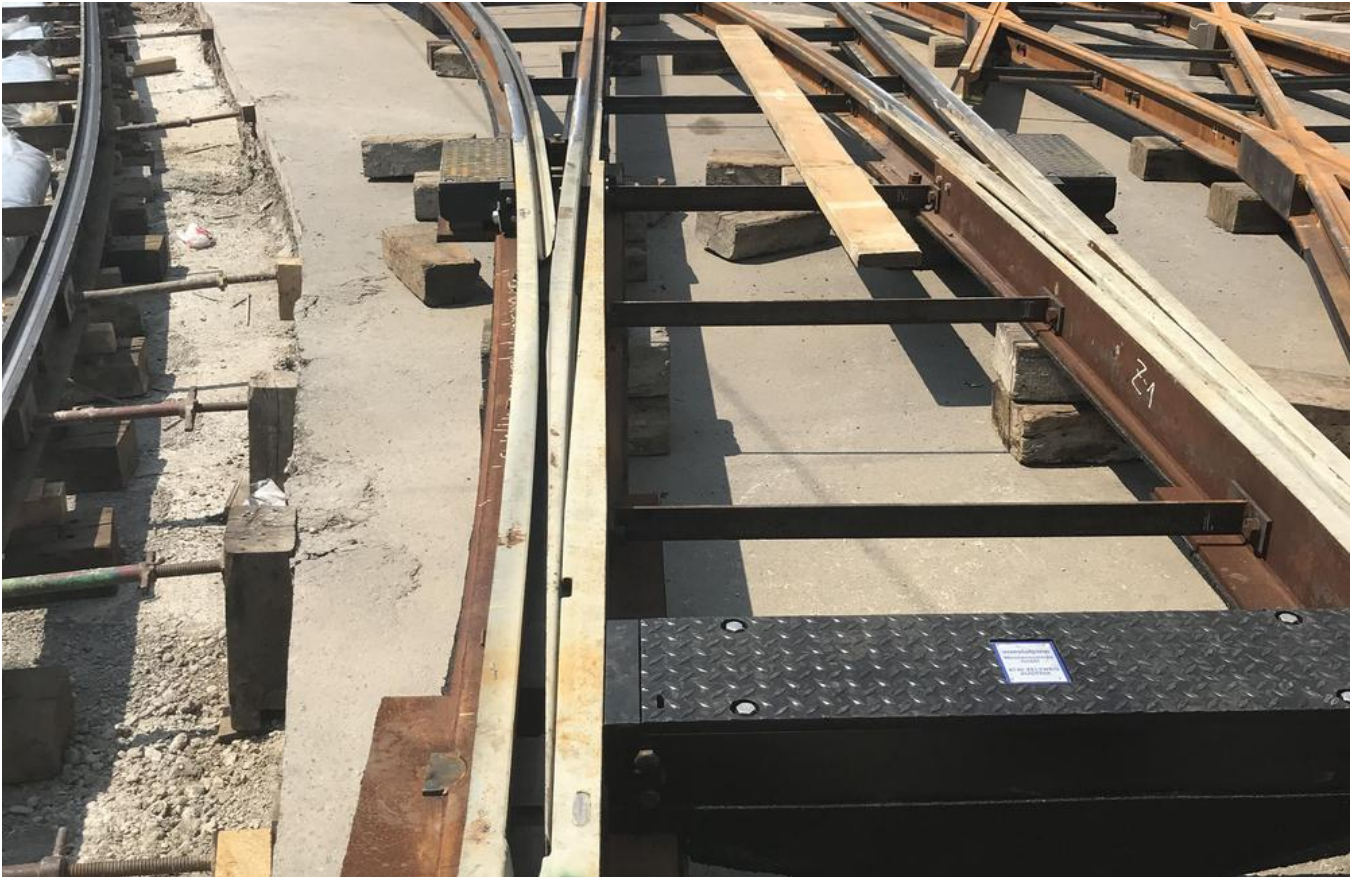
The grooved swivel plates for the intersection were pre-installed. Source: PORR AG

Once the surface concrete had hardened and the asphalt levelling course next to the track was in place, the second construction phase could begin. The southern part of Schlossohofer Strasse and the eastern half of the Brünner Strasse plateau were closed for this stage, which turned out to be the biggest challenge in the whole project. Altogether, 180 running metres of track, an intersection and a switch had to be renovated. A lot of time was saved by using a concrete milling machine for demolition in Schlossohofer Strasse. The excavator had to be brought in for the switches and intersection area. As the rails in the intersection were reaching the end of their service life, chiselling was carried out with great care, in order to avoid breaking any rails and thereby hindering the tram operation. The new switches and intersection were assembled ahead of installation on the construction site.

Replacing the switch and intersection, including a 9m track section, was a particularly delicate task, which had to be carried out during the night within a mere 3.5 hours. A large vehicle-mounted crane was used to remove the old, worn rails so that the two to six tonne new rail sections waiting at the side could be lifted into place. The rails were connected with iron plates until welded.

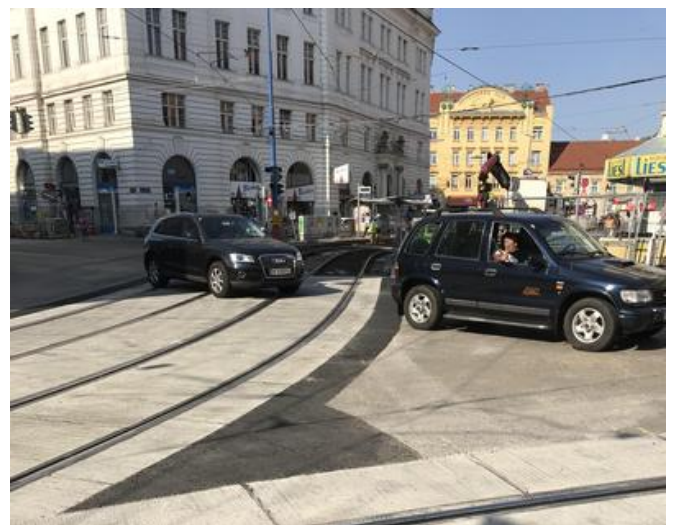
The road was usable very soon after the road surface concrete had been installed. Source: PORR AG

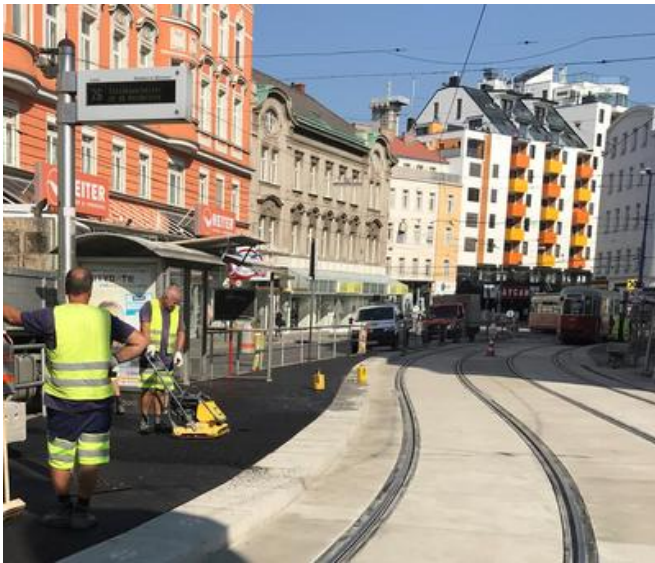
The final stage was to install asphalt between the guide wall element and the road at the tram stops. Source: PORR AG

The greater distance to the neighbouring buildings in the last two construction stages meant that the simpler sound-insulating superstructure could be used. While replacing the track, the existing track slabs were milled, aligned, and then concreted. For the very tight curve from Prager Strasse towards “Am Spitz”, a lubrication system was built at the start of the curve from each direction: the lubricating film minimises the squealing from the rails. This area also included two tram stops that needed to be renovated; they were closed for two weeks by Wiener Linien. Once the new guide wall elements had been laid, the asphalt surface was installed by PORR Civil engineering, Vienna branch.
