## FIRST-CLASS RENOVATION

### Sylvenstein Reservoir headrace tunnel

**In Bavaria's Isar Valley, PORR carried out badly needed renovations on the Sylvenstein Reservoir headrace tunnel.**

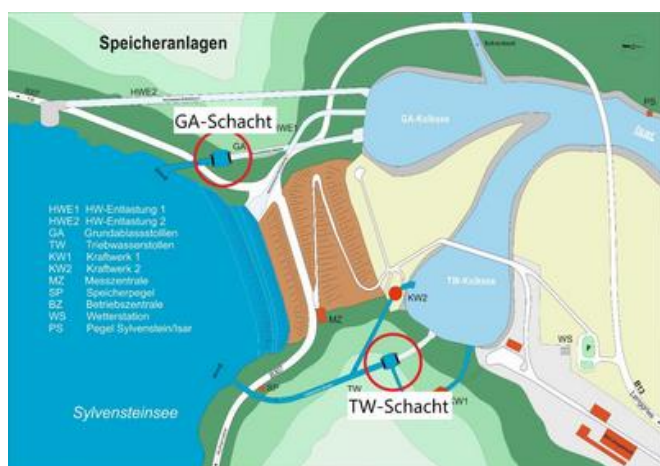
Overview plan of the Sylvenstein Reservoir, showing the sluice tunnel in the north and the headrace tunnel in the south. Source: Wasserwirtschaftsamt Weilheim

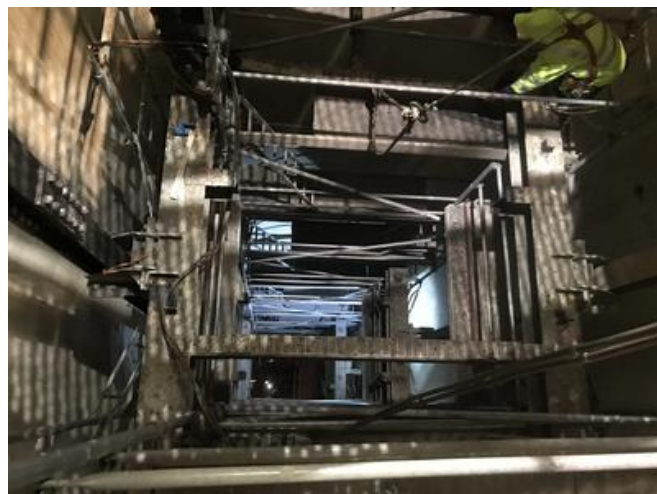
PORR built a 560 m<sup>3</sup> interior scaffold for safe removal of the steel parts. Source: PORR

According to the renovation plans, the existing 8m-wide, 42m-deep wet shaft was to remain in place. However, the top and bottom sluice gates and their drive mechanisms were to be replaced. The team began by removing all the steel parts that were no longer needed. The sluice gates, 4.5m high and 2.8m wide and weighing some 36 tonnes, were moved using electromechanical winches. These were positioned in a cavern that was only accessible via a steep and narrow – just 3m wide – route blasted into the rock. The bottom sluice gate was removed first – this was a two-part roller sluice gate with a hydraulic drive unit installed in the centre. About 560m<sup>3</sup> of interior scaffolding, plus a gantry with a 45m-long electric chain hoist, were installed for the dismantling and demolition work. The equipment was used to lift out the steel parts, slice them up and transport them away for stripping. Once the new bottom sluice gate had been manufactured and installed with the hydraulic steel construction, work began on demolition of the top sluice gate.

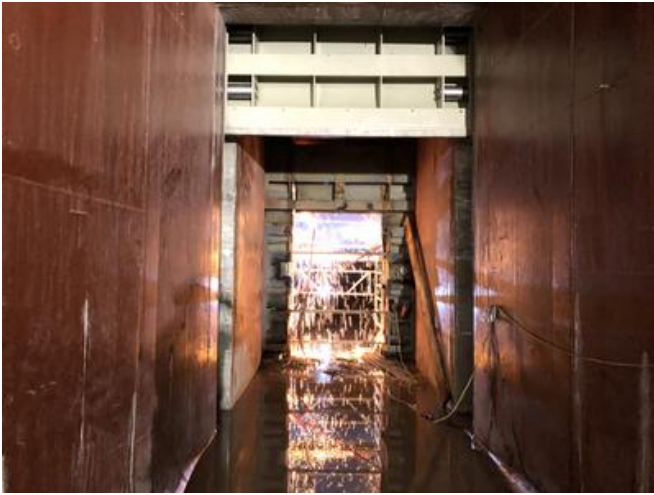
The PORR team worked under stringent safety measures as they painstakingly removed the 36t sluice gates piece by piece. Source: PORR

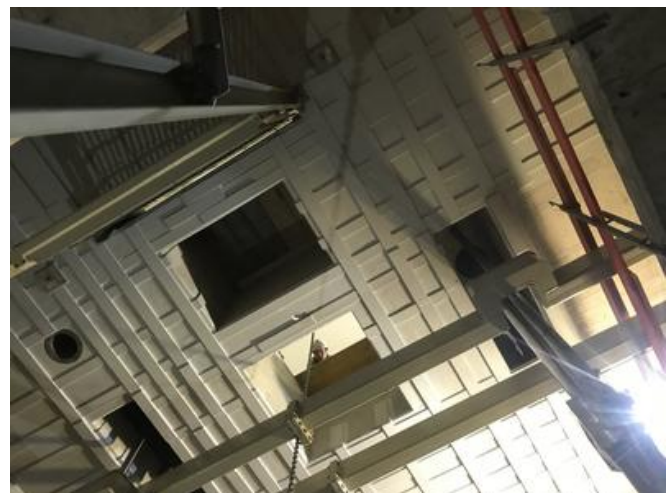
The cavern floor was structurally reinforced with CFRP fins. Source: PORR

One major challenge PORR faced was concreting the cavern floor. Due to tricky structural conditions, the concreting had to be done in a number of stages. To ensure characteristics suitable for the structural loads, approximately 2,300kg (≈ 260m) of CFRP fins had to be glued into crosses on the underneath of the cavern floor and anchored in place.

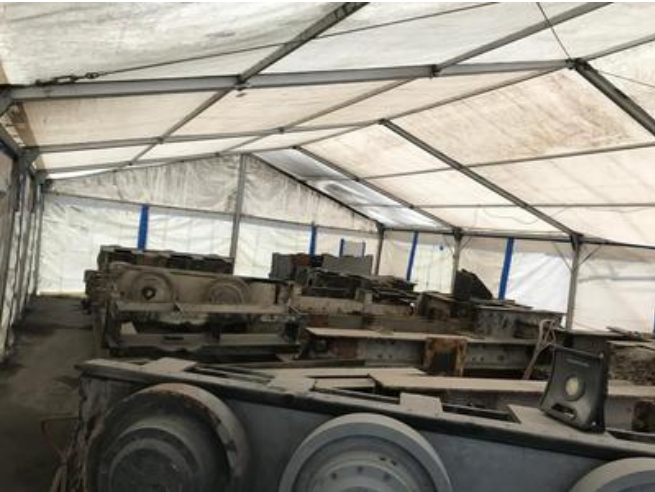
The team worked in a dust-tight treatment tent to strip the steel parts. Source: PORR

The teams coordinated with PORR Umwelttechnik for the task of stripping the old asbestos paint from the removed steel parts on the construction site and preparing them for subsequent disposal. A total of 29t of asbestos-contaminated grit and 65t of steel were professionally treated and disposed of.
