# Reconstruction of the Small Marchlehner Avalanche Gallery

## L 240 Venter Straße

Markus Kreuzer

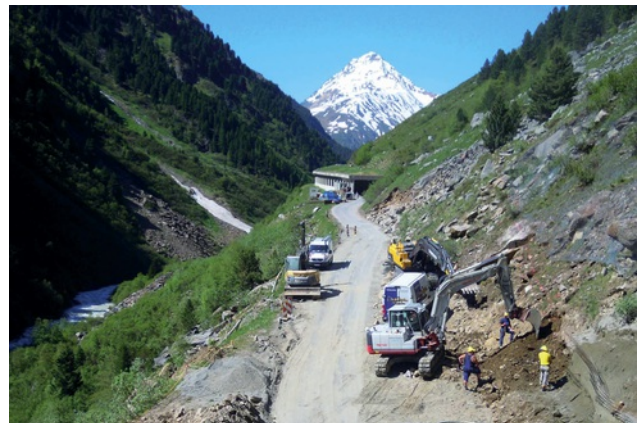
Rock stabilisation and excavation work  
Image: PORR AG

Rock was removed by means of blasting. In the area of the loose material, an anchored jetcrete wall was erected. In parts, the slopes reached heights of more than 8 m. Work had to be carried out while keeping the road open for traffic (single lane, controlled via light signal system - up to 1,000 vehicles per day). Only brief 10-minute traffic blocks for blasting and subsequent removal of rock material were permitted.

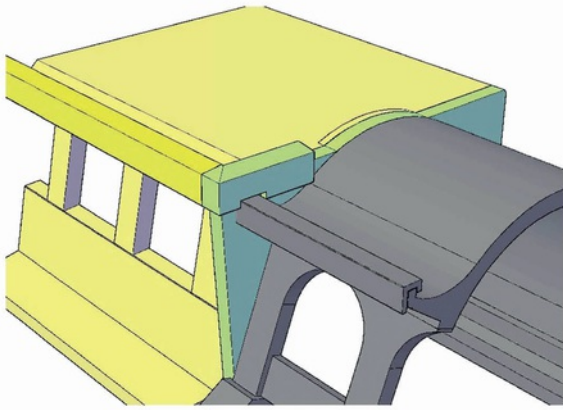
Transition – existing structure – new gallery  
Image: PORR AG

Since the existing Glasair gallery was executed as an arch superstructure, a 50 cm thick "transitional slab" to block 1 of the rectangular frame superstructure had to be installed first. Subsequently, the downhill and uphill strip foundations were constructed. Then, an 80 cm thick uphill wall was installed that was, however, only concreted up to a line two thirds the height of the frame structure. On the downhill side, 2.5 m high wall slabs with columns on top (cross-section 60/100 cm) were erected simultaneously. In mid-July 2013, the gallery form work carriage was set up (approx. 10 working days) and the first of a total of 19 superstructure blocks was cast. On average, two blocks per week were installed until the end of this work in September.

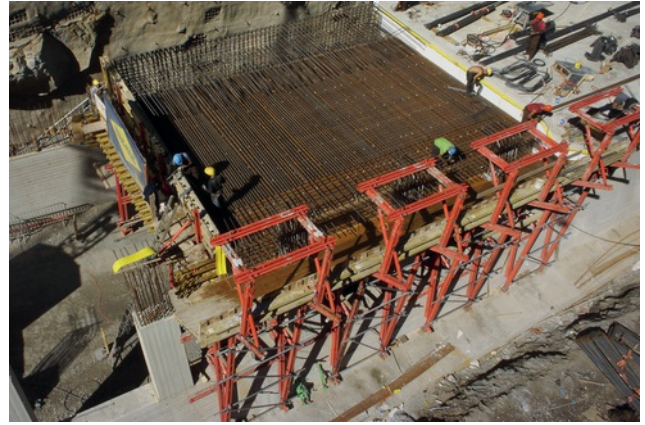
Laying of reinforcements at frame superstructure  
Image: PORR AG

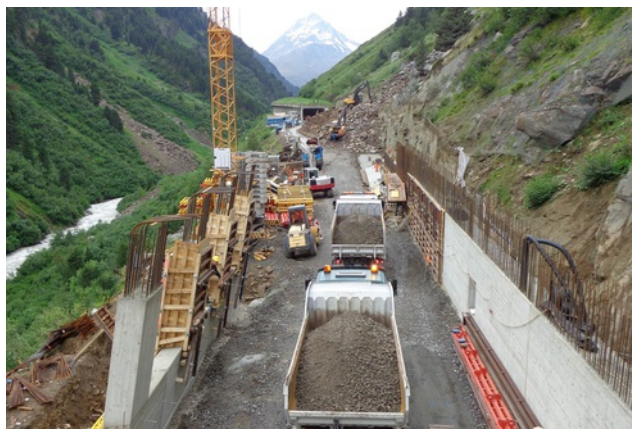
Downhill wall columns  
Image: PORR AG

The small Marchlehner gallery has a length of some 228 m and has been constructed in 19 block sections of 12 m each. On a length of 180 m, the gallery's structure was executed as a level frame including separate downhill wall panels with openings of 2.7 m x 3 m ("column structure") as a rectangular cross section and in the area of the ramp, on a length of approx. 45 m, as a closed design. The clear internal cross-section of the gallery is 8.25 m x 4.9 m. Strip foundations were used on both uphill and downhill.

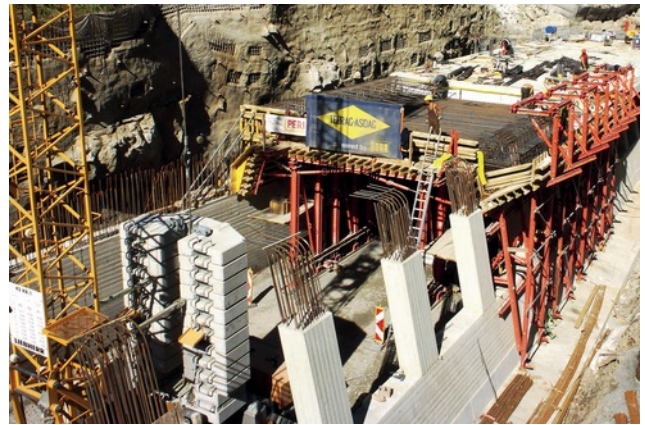
Laying of reinforcements at frame superstructure  
Image: PORR AG

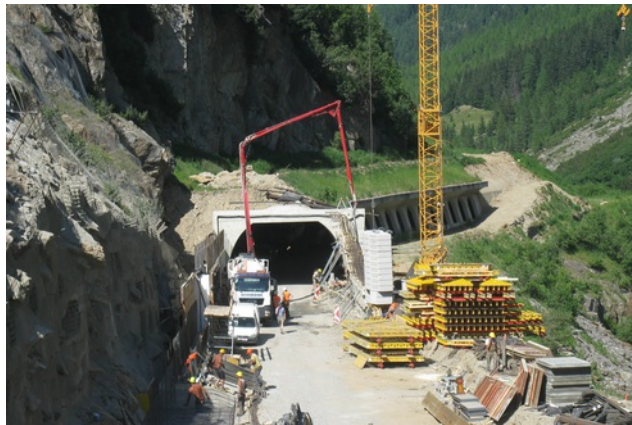
Uphill strip foundations  
Image: PORR AG

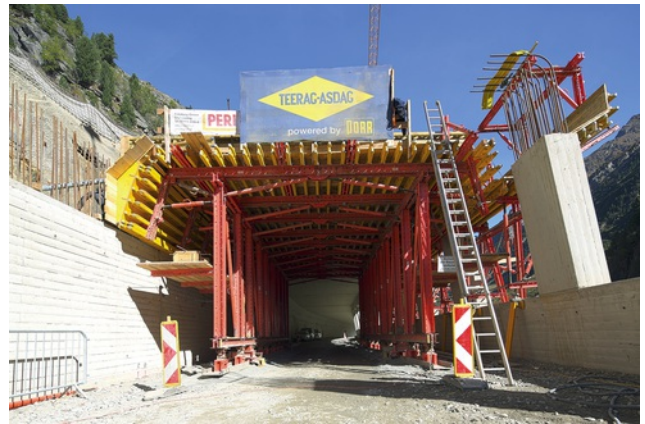
Gallery form work carriage  
Image: PORR AG

During the entire construction period, traffic had to be guided through a clear space 3 m wide and 4.5 m high across the building site and therefore also through the form work carriage since closing down the L 240 Venter Straße in the area of the construction section was impossible. Construction work commenced in June 2013. According to the building contract, the main construction work – gallery structure including roadworks – had to be completed by November 2013. Outstanding work was carried out in spring of 2014.

Due to the fact that the traffic had to be guided underneath the form work carriage it posed a great challenge to use the confined spatial conditions of the intermediate storage areas at the downhill edge of the building site. At the same time as the construction of the gallery structure took place, the uphill drainage holes and drainage lines for the draining of slope waters had to be installed. Also, sealing work on the gallery had to be drawn in. After completion of the gallery structure, a 50 m access ramp to the gallery's roof and the 180 m long edge beam on the gallery's cantilever arm were built.

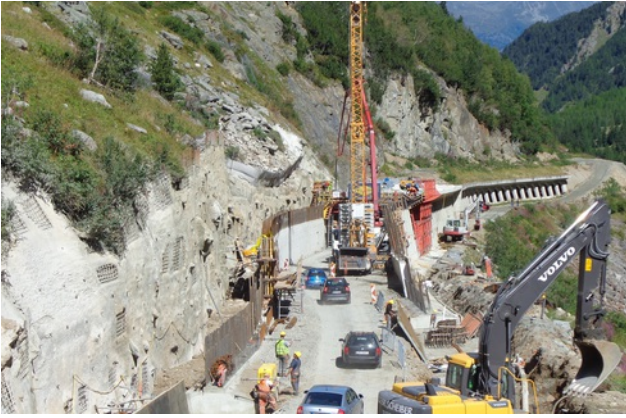
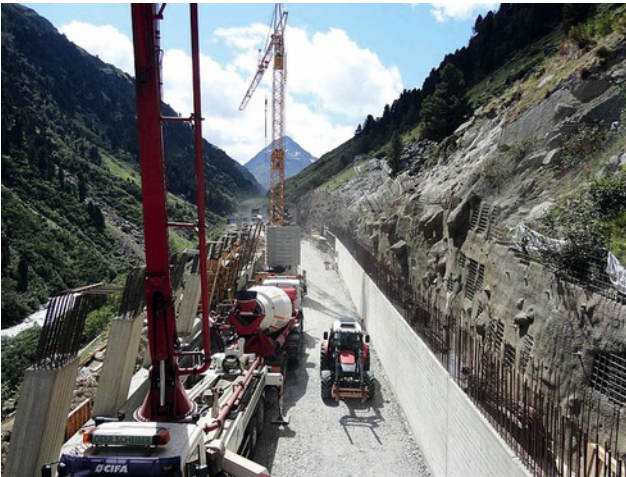
Keeping the road open for traffic  
Image: PORR AG

Roadworks in the area of the carriageway were carried out on one lane at a time to be able to keep the road open for traffic. The uphill slope waters were being separately collected using drainage lines and guided into the Venter Bach stream via three drainage holes.

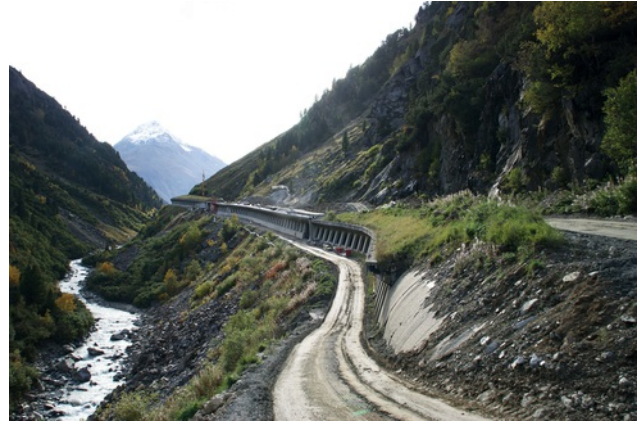
Access road to intermediate dumping area  
Image: PORR AG

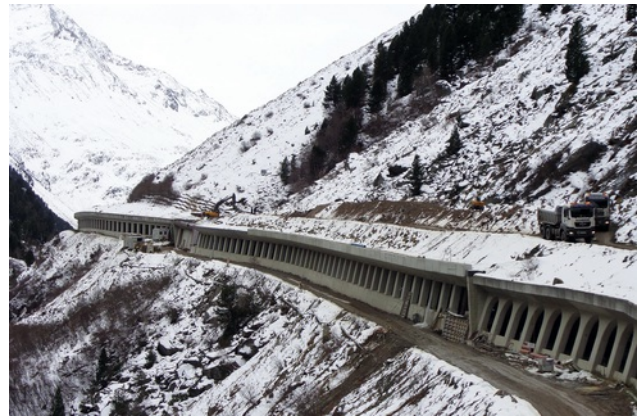
State of construction November 2013  
Image: PORR AG

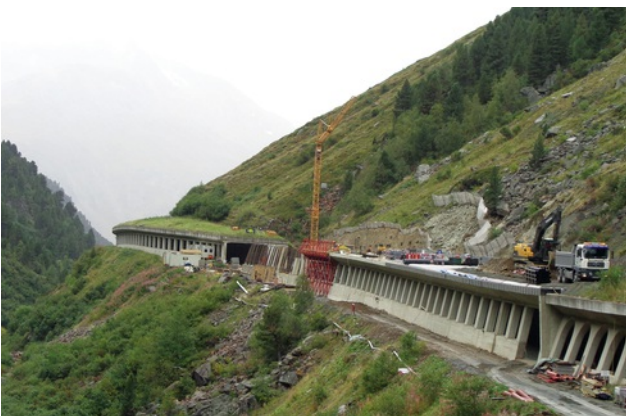
State of construction September 2013  
Image: PORR AG

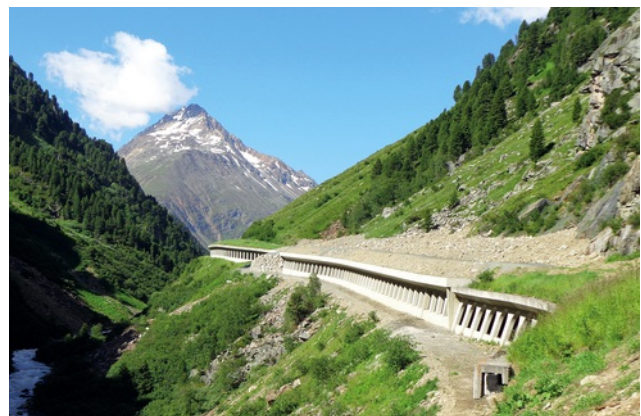
Completion of construction in summer 2014  
Image: PORR AG
