GENERAL REHABILITATION OF AUSTRIA'S MOST HEAVILY FREQUENTED ROAD

A23 Inzersdorf elevated highway

Author: Franz Hrebik

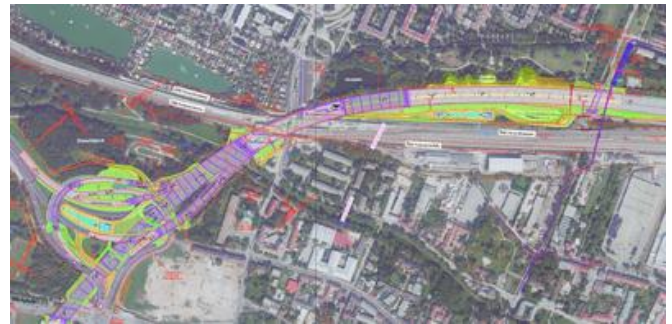
The Inzersdorf elevated highway on the south-east Vienna ring road is one of the busiest traffic intersections in Austria. Source: PORR

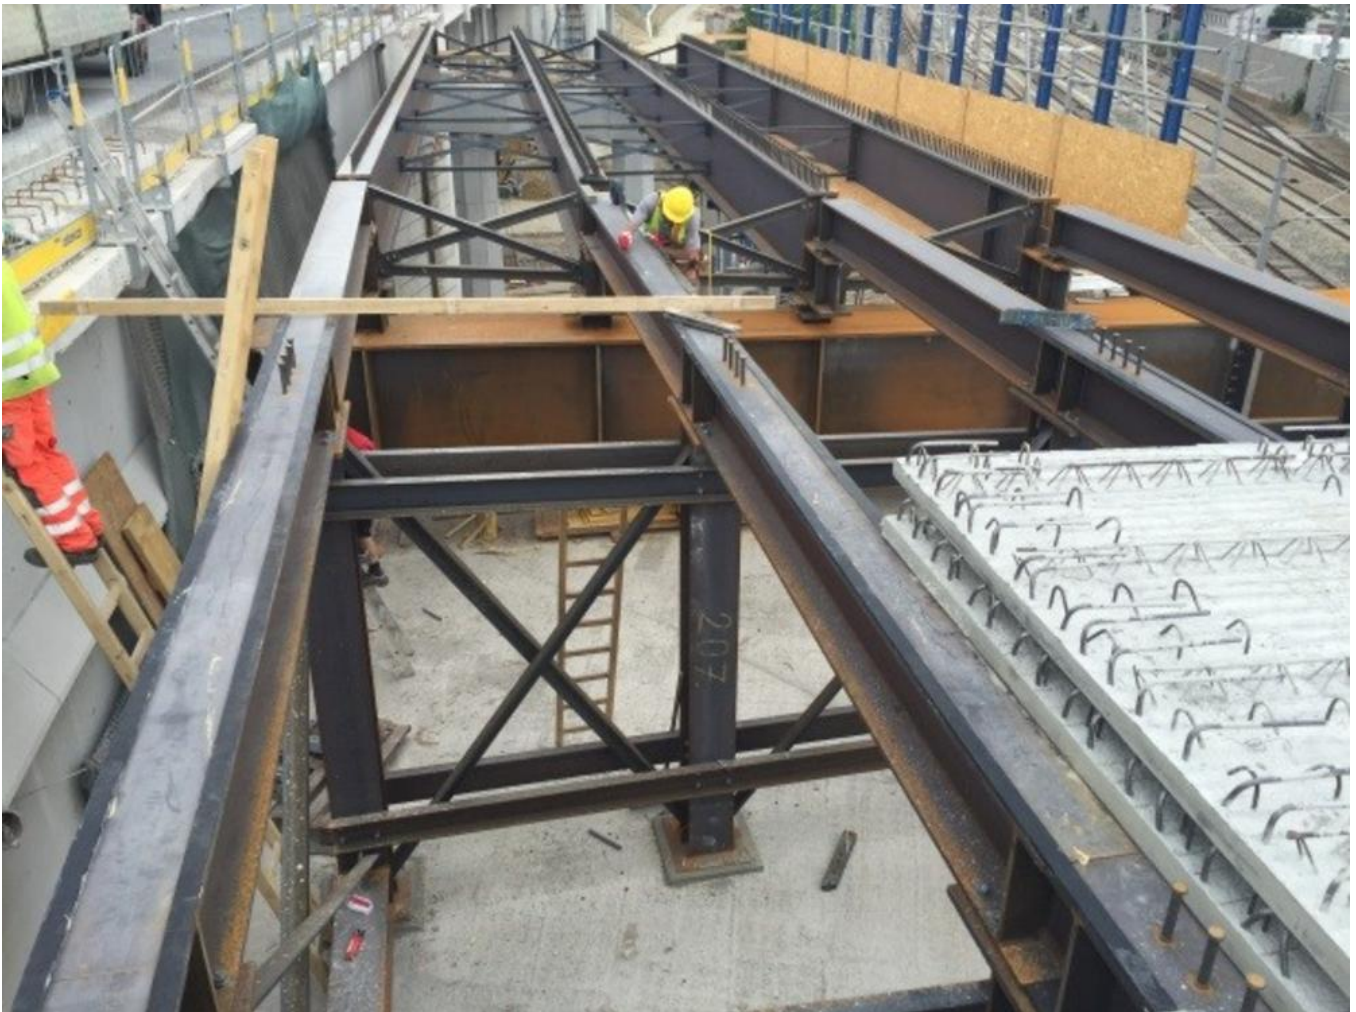
To create space for the construction site facilities and maintain ongoing traffic, the lanes were temporarily widened with the aid of composite steel bridges. Source: PORR

Before demolition of the bridge structures could begin, the existing lane had to be widened. With the aid of a composite steel bridge 2m to 7m wide, a temporary supporting structure was erected which was designed for a service life of two years.

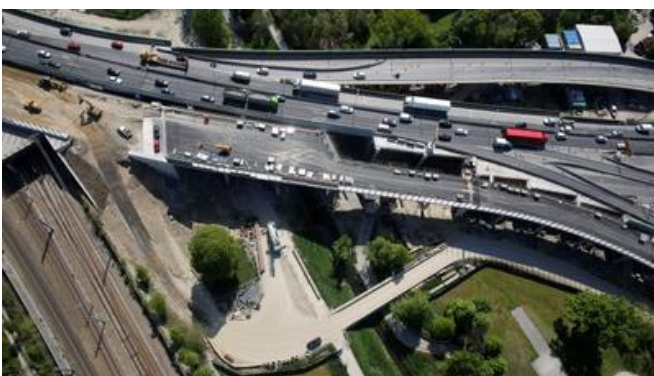
Several bridges were completely or partially rebuilt and an existing tunnel was backfilled. Source: PORR

After demolition of the northern lanes, several bridges were partially or completely rebuilt and a new overpass was erected. Once the structures just above it had been demolished and the new lanes constructed, an existing railway tunnel was backfilled with a mixture of conventional filling material and foam glass ballast to save weight.

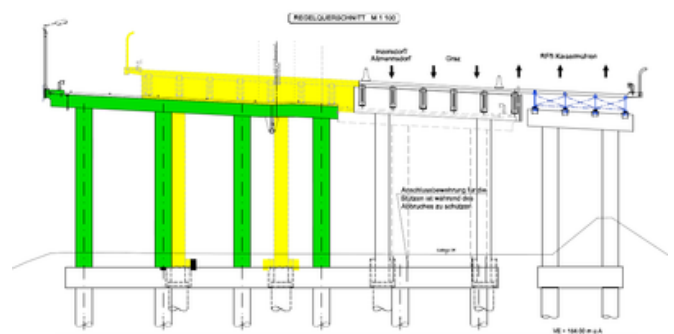
Overview of the phased construction. Source: PORR
