PROGRESS: 100% - COMPLETED
AUSTRIA

GENERAL REHABILITATION OF AUSTRIA'S MOST HEAVILY FREQUENTED ROAD

A23 Inzersdorf elevated highway

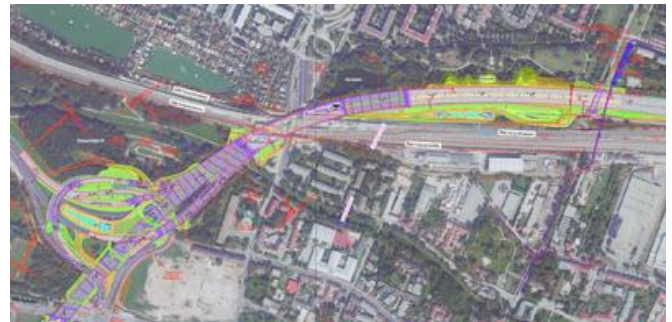
The Inzersdorf elevated highway on the south-east Vienna ring road is one of the busiest traffic intersections in Austria. Source: PORR

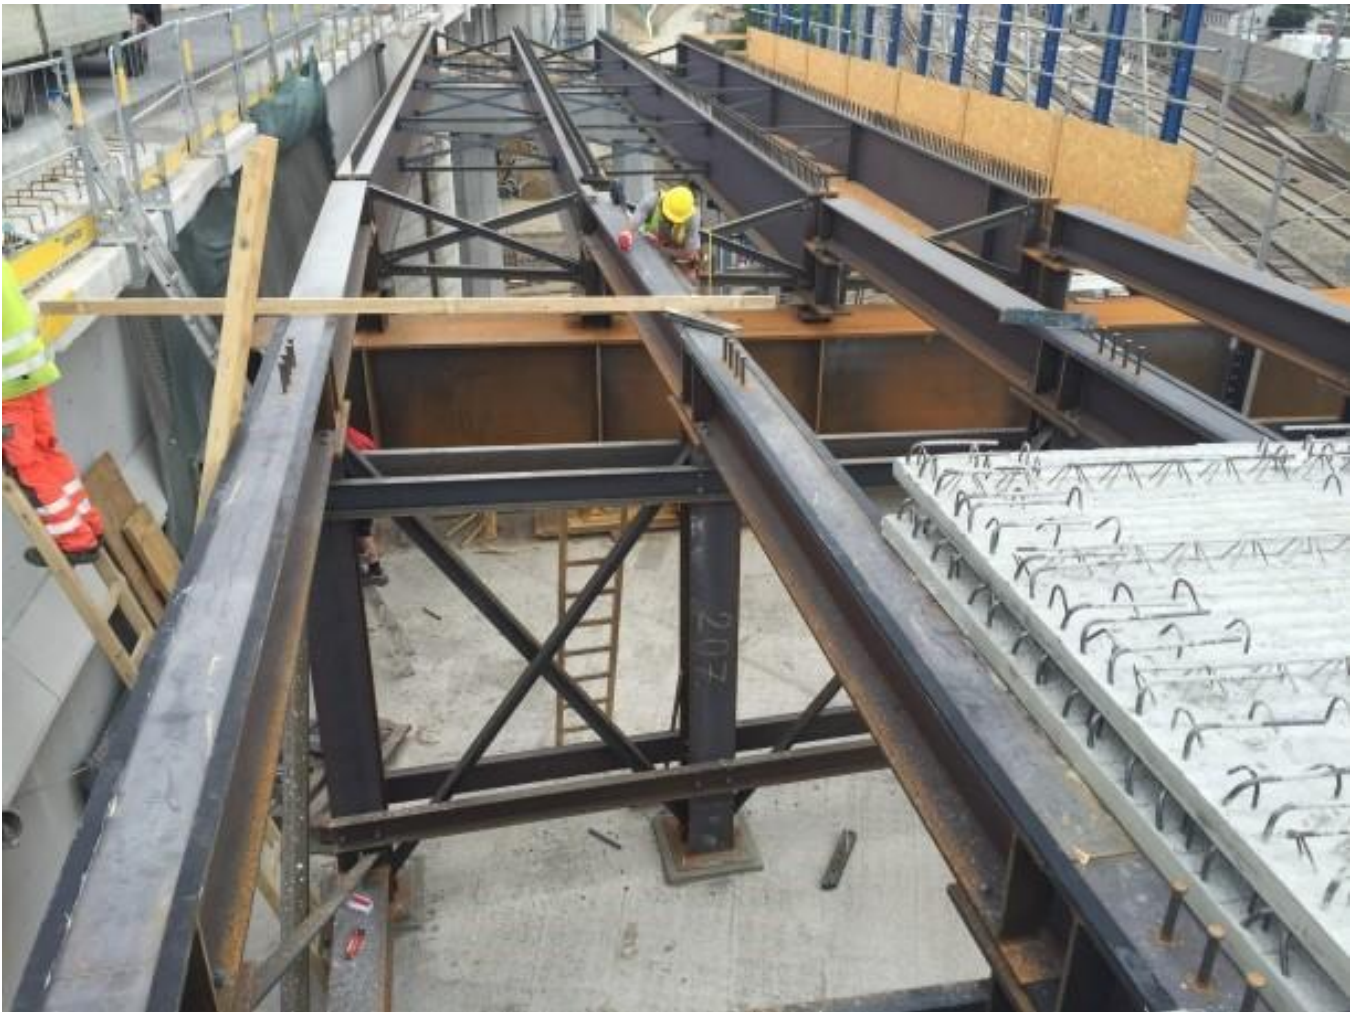
To create space for the construction site facilities and maintain ongoing traffic, the lanes were temporarily widened with the aid of composite steel bridges. Source: PORR

Before demolition of the bridge structures could begin, the existing lane had to be widened. With the aid of a composite steel bridge 2m to 7m wide, a temporary supporting structure was erected which was designed for a service life of two years.

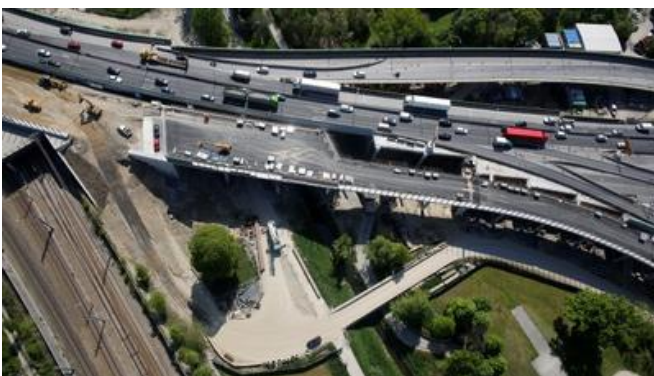
Several bridges were completely or partially rebuilt and an existing tunnel was backfilled. Source: PORR

After demolition of the northern lanes, several bridges were partially or completely rebuilt and a new overpass was erected. Once the structures just above it had been demolished and the new lanes constructed, an existing railway tunnel was backfilled with a mixture of conventional filling material and foam glass ballast to save weight.

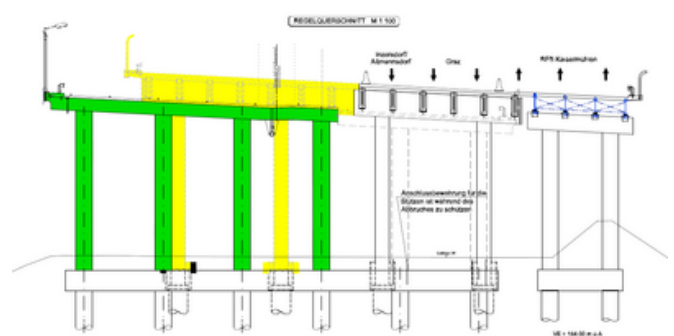
Overview of the phased construction. Source: PORR

Phases 3 to 5 focused on the Altmannsdorf/Inzersdorf exit intersection. Since all the relations of the individual constructions had to be preserved, the structures had to be built in sections. Due to the limited space available and the small working area, this required a high degree of coordination. For example, the location of the crane had to be carefully selected to ensure that the crane boom would not swing out across the carriageways. At the same time, it was also possible to build two additional bridges during these phases.
