HUNDREDS OF ANCHORS **IMPROVE SAFETY**

Renovating the Hochmais and Frauenegg anchor walls

PORR is working alongside the A10 Tauern Motorway to bring two aging anchor walls up to date with the latest technology, and thus guarantee improved safety.

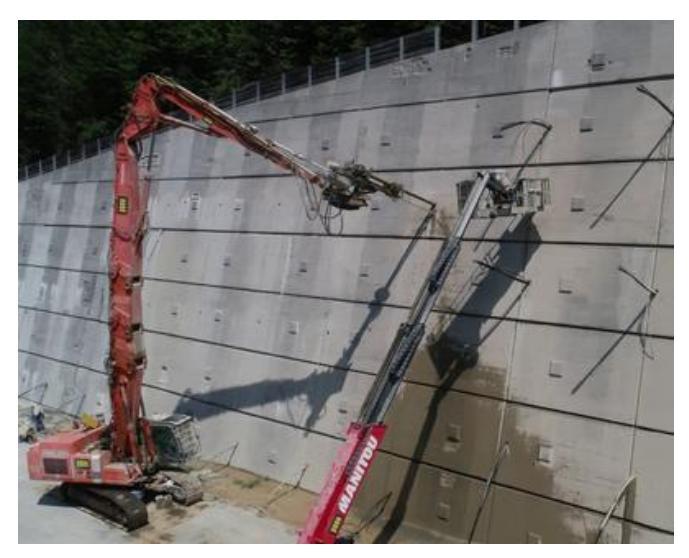
A 60t excavator with carriage attachment was used for drilling at heights of up to 20m. Source: PORR Specialist civil engineering

PORR installed the new anchors on the 25m high Hochmais anchor wall at three levels. The bottom level was installed using a crawler drill rig, while a 60t excavator with a carriage attachment on its arm was used to drill the anchor holes in the higher levels at heights of up to 20m. The mechanical installation followed safely using an anchor dispenser. Altogether, 167 permanent strand anchors were installed on the Hochmais anchor wall – 4,615m of anchors in total. The individual anchors are up to 36m long with a breaking load of 2,790kN.

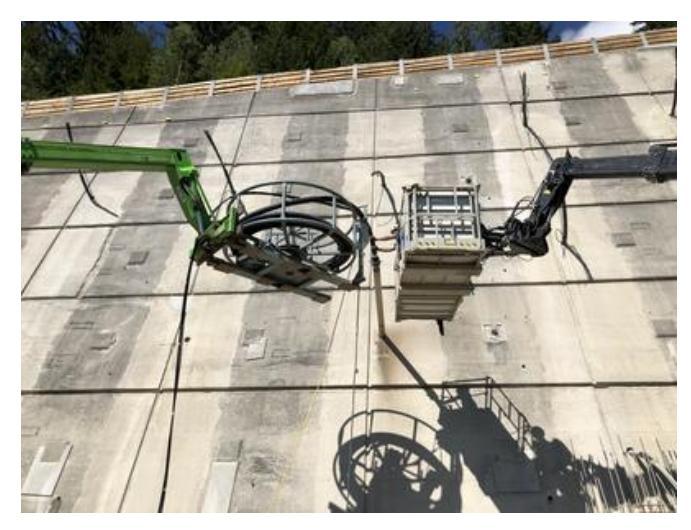
Altogether, 167 permanent strand anchors were installed on the Hochmais anchor wall, making 4,615m of anchors in total. Source: PORR Specialist civil engineering

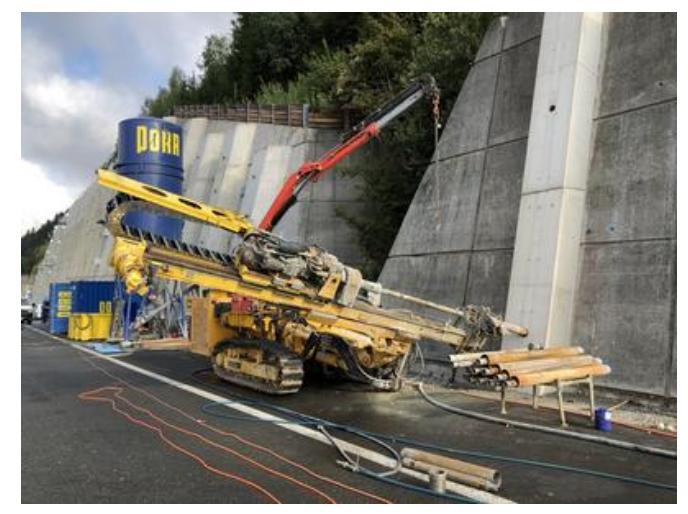
The drill holes in the lower level were drilled using a crawler drill rig. Source: PORR Specialist civil engineering

The new anchors in the 11m high Frauenegg anchor wall were installed on two levels. As before, the crawler drill rig was used for the lower level, and two 20t excavators with carriage attachments were used to reach the higher level at 9m. The anchor dispenser came back into action for the strand anchors, while the bar anchors were installed with an I-beam specially constructed by PORR. Altogether, 234 permanent strand and bar anchors were installed on the Frauenegg anchor wall – 5,023m of anchors in total. The individual anchors are up to 26m long with a breaking load of 2,232kN.

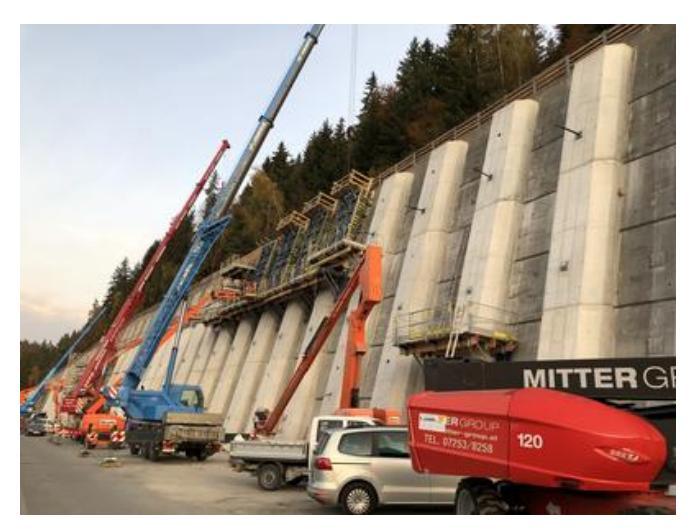
The pilaster strips on the anchor wall were concreted after the anchor holes had been drilled. Source: PORR Specialist civil engineering

The PORR team used a double rotary drilling procedure. In this procedure, two separate rotary drives are used to drill the casing and auger into the bedrock. The casing supports the drilled hole, while the auger, tipped with the boring head, travels slightly ahead to rotate and break up the bedrock. The loose material is then flushed out of the drilled hole with air and water. In the 'right-left' system, the casing rotates anti-clockwise and the auger clockwise to ensure a good drilling performance. Once the anchors had been installed, the drill holes were filled with cement grout. The following day, the grout was injected into the bond using a highpressure process. This holds the anchor in the bedrock. The grouting process was repeated until the required retaining pressure was reached. The vertical pilaster strips on the Hochmais anchor wall were concreted after the anchor holes had been drilled; on the Frauenegg wall, some were concreted beforehand. In order to ensure that the pilaster strips had sufficient concrete strength to prestress the anchors, it was essential to wait the full hardening time.

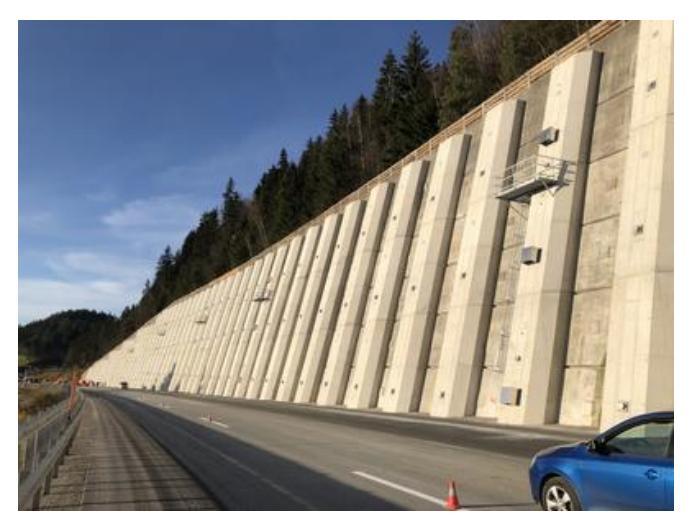
Regular monitoring of the anchor walls is facilitated by fifteen measurement cross-sections, fitted with 32 force plates and 25 extensometers. Source: PORR Specialist civil engineering

Measurement cross-sections were built to facilitate continuous monitoring of the anchor walls. Force plates were installed so that potential changes to the anchor forces can be identified quickly, while extensometers measure any movement in the walls. Six measurement cross-sections were built in the Hochmais anchor wall, comprising seventeen force plates and twelve extensometers, with a total length of 410m. The Frauenegg anchor wall has nine measurement cross-sections comprising fifteen force plates and thirteen extensometers, with a total length of 350m.
