FIRST CONCRETE ROAD SURFACE TECHNOLOGY PROJECT FOR PORR A.S.

D2 motorway restoration in the Czech Republic

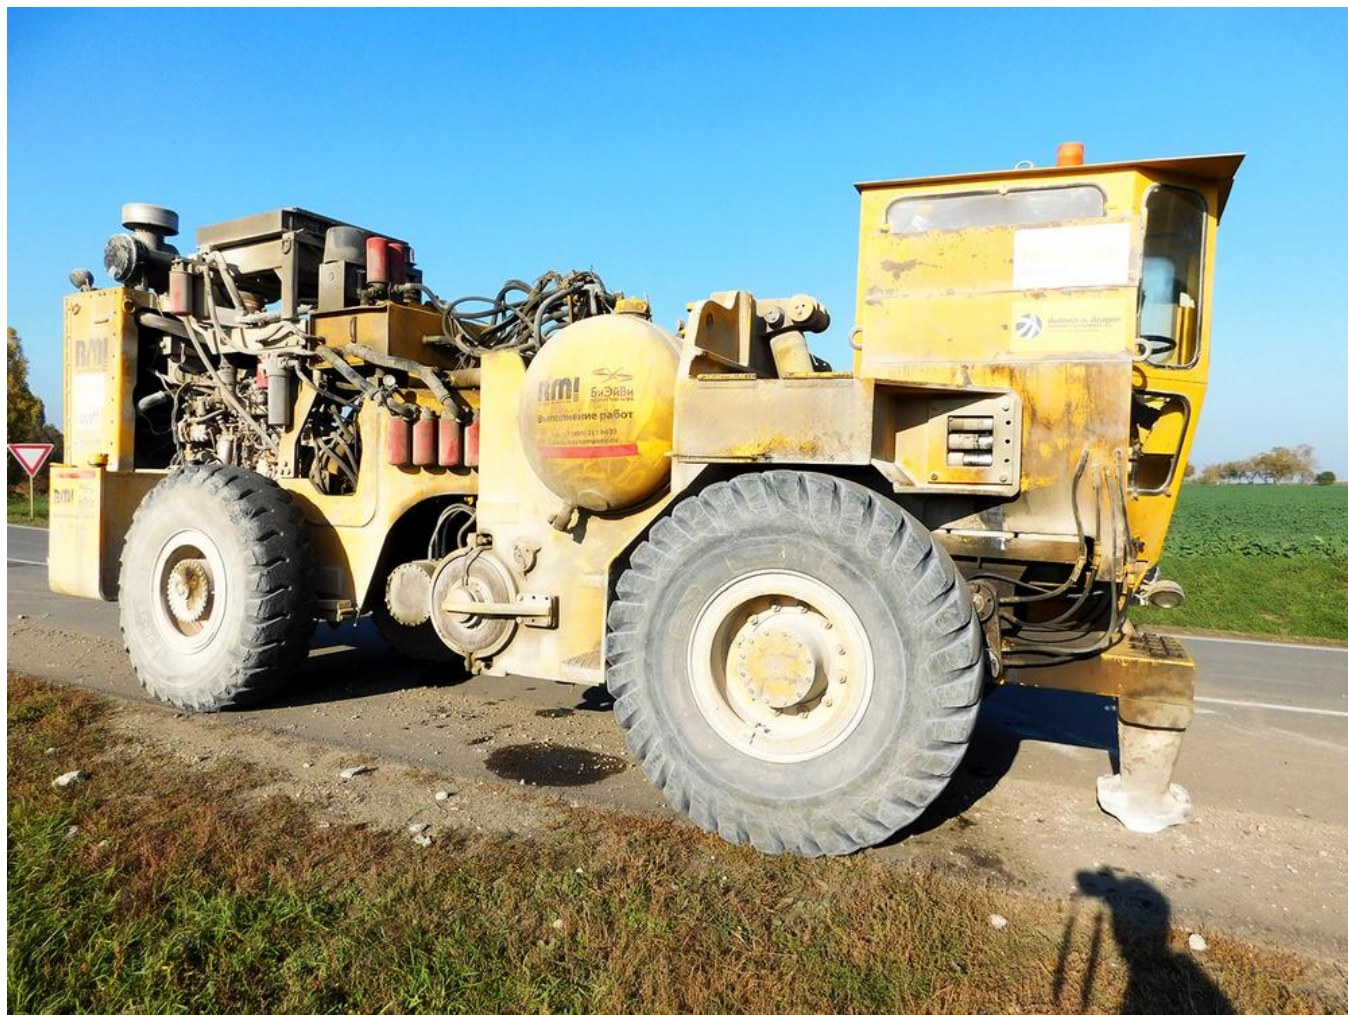
RB 500 resonance breaker – construction machine for demolishing the concrete substructure. Image: PORR AG

During the first step, the existing roadway surface was rubblised with a resonance concrete breaker. This proved to be an efficient and effective measure for removing the concrete slabs. This construction machine, model RB 500, was able to literally crush the existing cement concrete in a short period of time, operating at higher frequency (55Hz) and lower amplitude (19mm). Some 18,000m³ of rubble was accumulated in total, which was later recycled into the new construction.

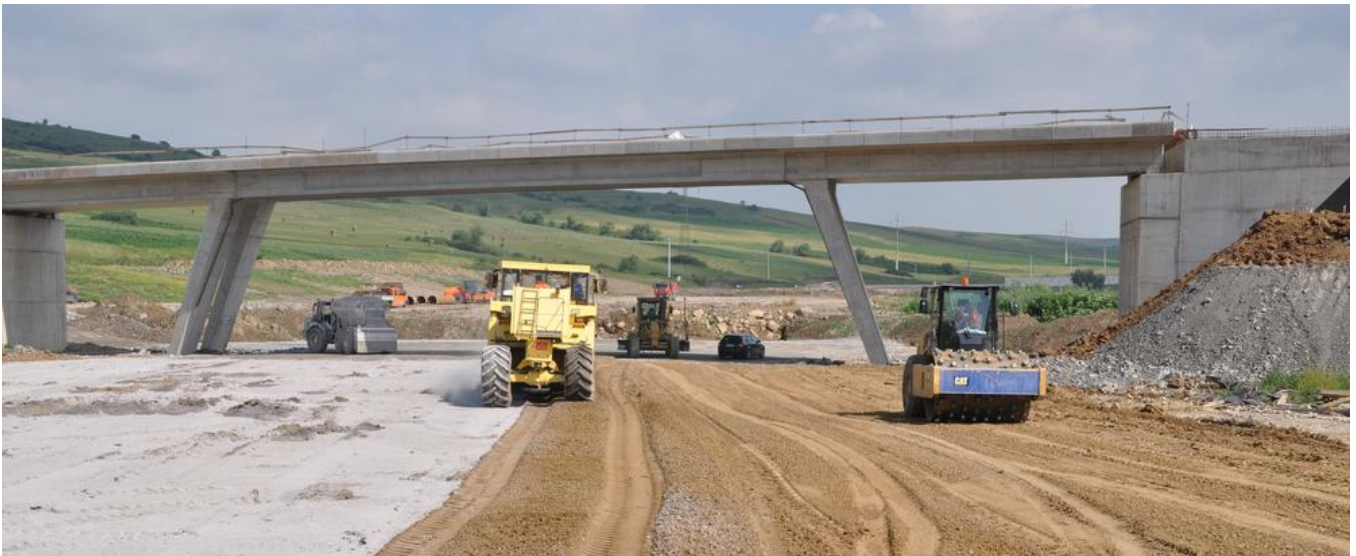
Demolished concrete surface with cleaned central line markings. Image: PORR AG

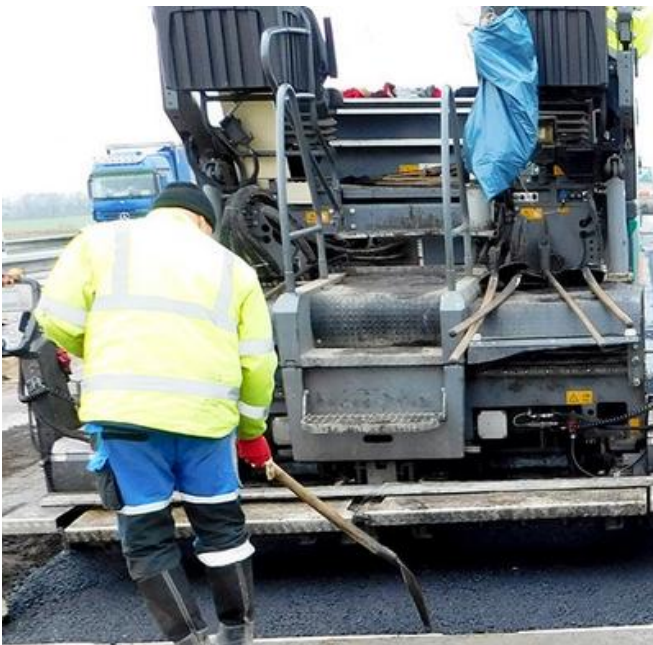
Laying of the compacted bitumen intermediate layers. Image: PORR AG

Diagnostic inspections before works commenced allowed PORR specialists to determine that the existing 240mm-thick concrete surface would need to be demolished, a 40mm-thick bitumen intermediate layer inserted and the substructure bolstered by a 120mm-thick layer of cement stabilisation. Only then was a new two-layer 270mm-thick concrete surface, making use of the recycled materials from the demolished concrete surface, to be applied.
