PROGRESS: 100% - COMPLETED
CZECH REPUBLIC/2017-17

FIRST CONCRETE ROAD SURFACE TECHNOLOGY PROJECT FOR PORR A.S.

D2 motorway restoration in the Czech Republic

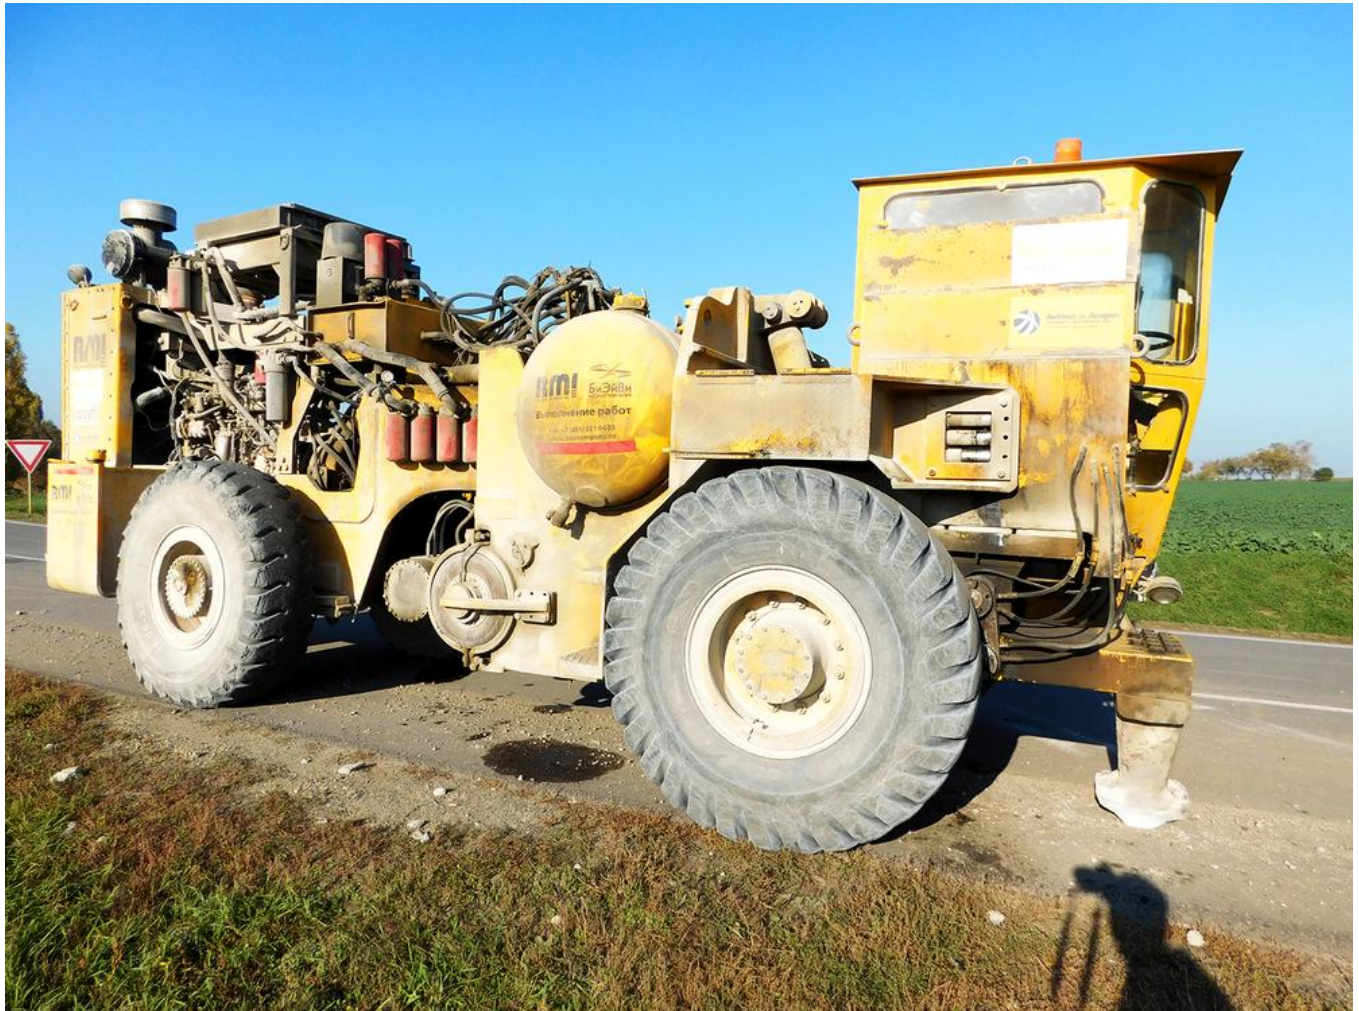
RB 500 resonance breaker – construction machine for demolishing the concrete substructure. Image: PORR AG

During the first step, the existing roadway surface was rubblised with a resonance concrete breaker. This proved to be an efficient and effective measure for removing the concrete slabs. This construction machine, model RB 500, was able to literally crush the existing cement concrete in a short period of time, operating at higher frequency (55Hz) and lower amplitude (19mm). Some 18,000m³ of rubble was accumulated in total, which was later recycled into the new construction.

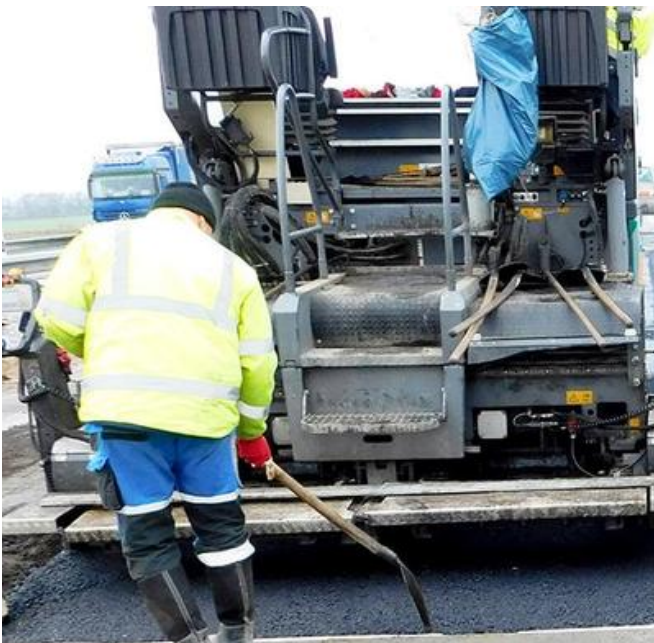
Laying of the compacted bitumen intermediate layers. Image: PORR AG

Diagnostic inspections before works commenced allowed PORR specialists to determine that the existing 240mm-thick concrete surface would need to be demolished, a 40mm-thick bitumen intermediate layer inserted and the substructure bolstered by a 120mm-thick layer of cement stabilisation. Only then was a new two-layer 270mm-thick concrete surface, making use of the recycled materials from the demolished concrete surface, to be applied.
