GENERAL RENOVATION OF A HISTORICAL HEALTH FACILITY

PROGRESS: 100% - COMPLETED
AUSTRIA/WIEN/2016-18

Pavilion 1 of Vienna's Hietzing Hospital

PORR carried out an extensive general renovation of the Hietzing Hospital, Pavilion 1, in compliance with strict regulations for the heritage-listed building.

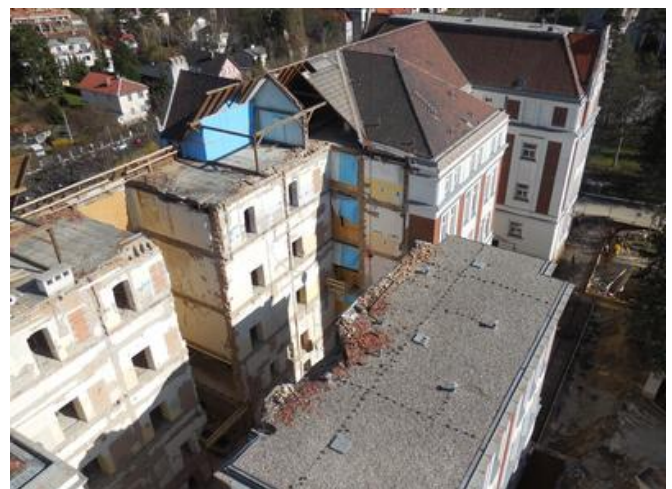
A view from the crane cab shows the vast scope of the structurally challenging demolition work. Source: PORR

Before it was possible to begin the extensive demolition work, structural strengthening measures had to be carried out for the load-bearing components, so that additional shafts for building services, lift shafts and staircases could be built. In addition, the below-ground level had to be secured and dried out. In order to create valuable space in the basement, the metre-thick brick walls were treated with suitable injections.

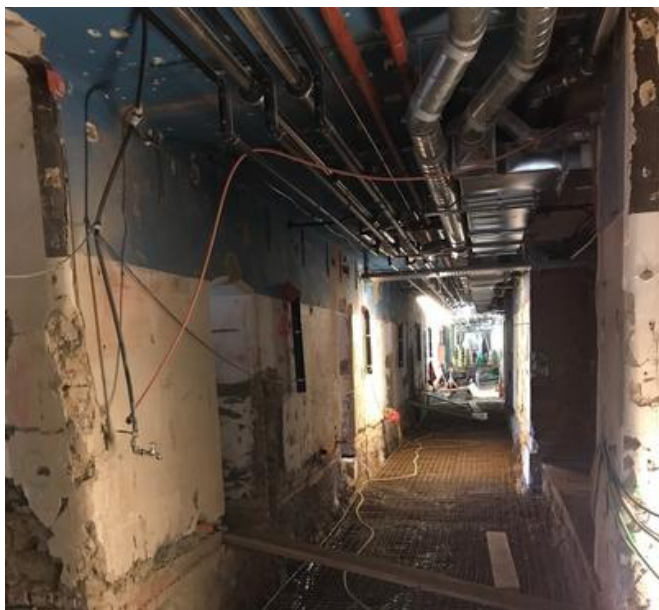
The metre-thick brick walls in the lower floor were dried out using injections. Source: PORR

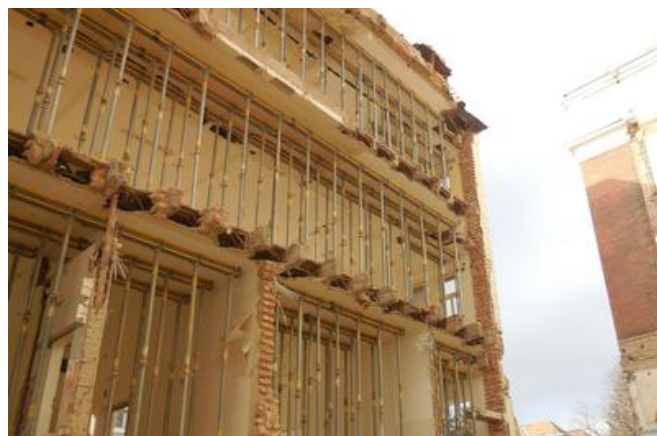
The ceilings had to be shored up and secured with underpinnings several times during the demolition work. Source: PORR

The new spatial concept in Pavilion 1 enlarged the building with an underground garage and two extensions for offices. The particular challenge here was to secure the fragile existing building with suitable underpinnings. During demolition of the external hull, the ceilings had to be shored up several times with stiffening grilles and heavy-duty scaffolding.

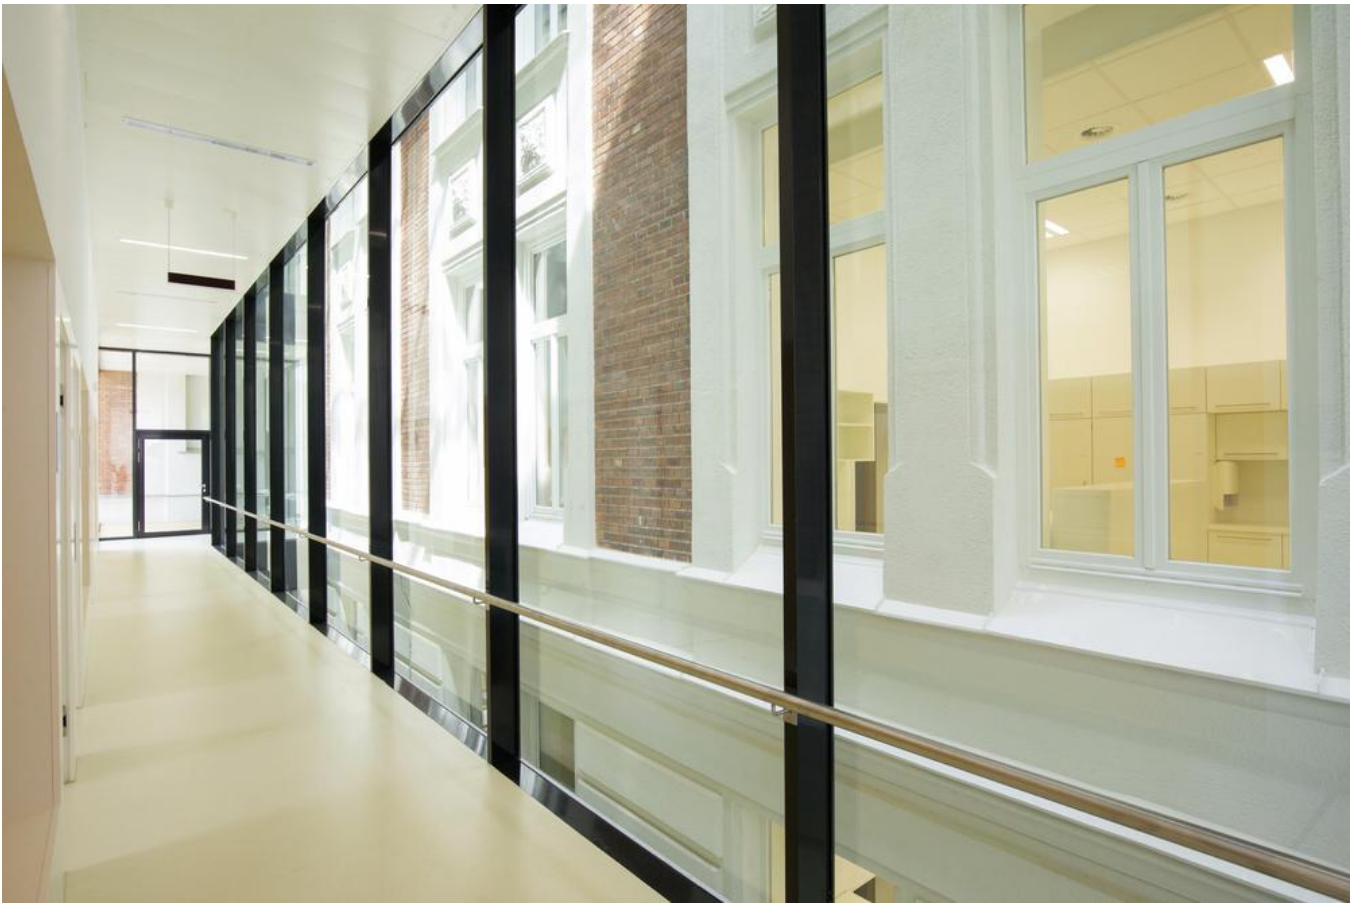
The ingenious architecture lets natural light into the original spaces despite the additions. Source: Fotostudio Semrad
