GROUNDWORK FOR A NEW AIRPORT

Brasov International Airport

PORR is building a runway, an apron and a comprehensive drainage network for Transylvania's new airport in Brasov.

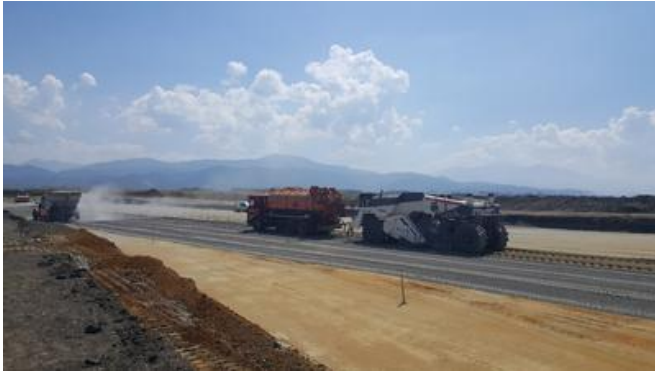
A 25cm thick stabilised ballast layer was laid on top of the lower ballast layer for the taxiway and apron. Source: PORR Construct

The next stage of the structural work for the apron and taxiway was to create a 40cm thick ballast base course. A further 25cm thick course of stabilised ballast was then laid on top of this. Cable ducts were incorporated into the stabilised ballast, so that the power supply cables for the taxiway lights could be laid in the ground. The shoulder was constructed from a base course consisting of 35cm thick ballast beneath a 25cm course of stabilised ballast.

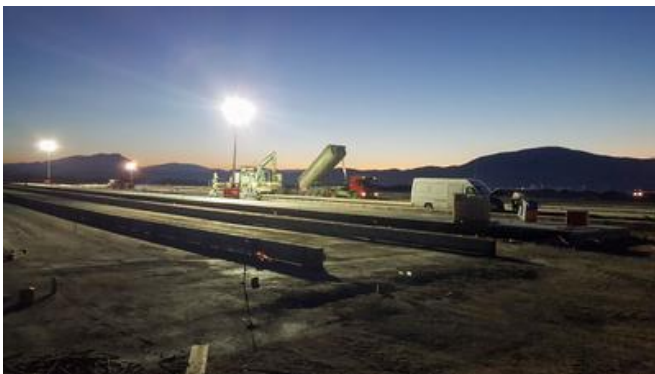
Solid steel girders were used as formwork for the concrete layer. Source: PORR Construct

Solid steel girders were used as formwork for the concrete layer. The project was particularly challenging due to the short construction period, which meant that work had to be done around the clock, including weekends.

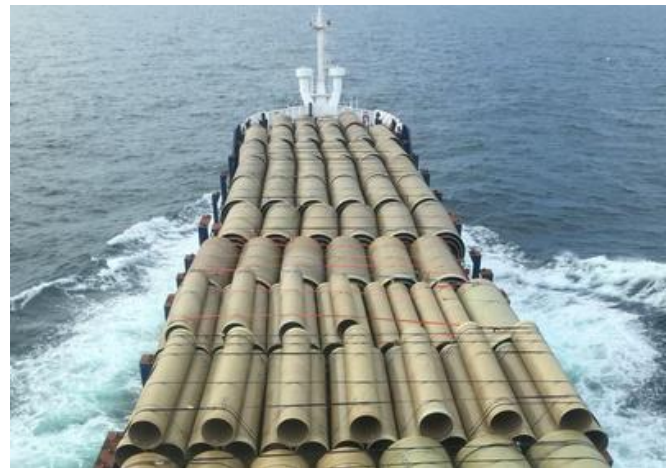
The pipes for the rainwater draining system were delivered from Turkey on two ships. Source: PORR Construct

In just two months, 12km of GRP pipes (DN 500–DN 2000) were manufactured in Turkey and delivered to Romania for the rainwater drainage channels. They were transported to Constanta by two ships and then transferred onto a total of 223 lorries. The first transport had to include every type of pipe, so that work could begin immediately. This was made possible by the collaboration with the excellent delivery contractor APS, who was also responsible for delivering the GRP manholes and concrete manholes.

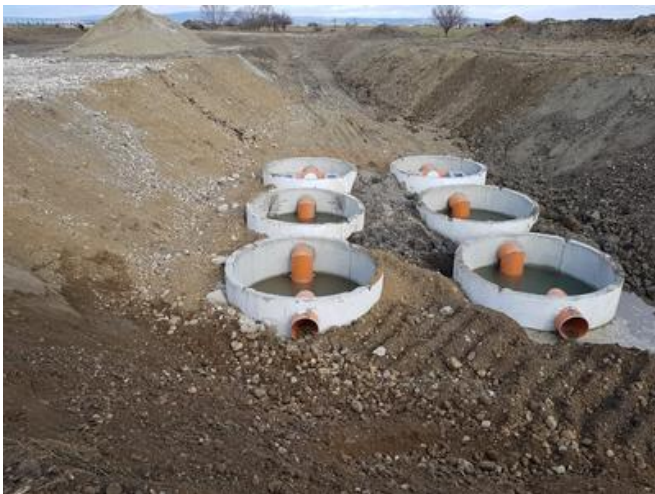
Water is cleaned in the two-stage oil separator system. Source: PORR Construct

The water collected in the drainage network is transported through the GRP pipes to two oil separators that remove impurities from the water. Each separator has a capacity of 440l/sec and there is also a bypass with a capacity of 1,200l/sec.

Installing the oil separators was a significant challenge due to the high groundwater level: we hit water after just one metre of excavation and had to pump it away continuously. A 15cm ballast layer was installed after the required depth was reached. A concrete course, also 15cm thick, followed. Once the separators were in place, the filling began with layers of 20cm thickness of soil, reaching the top sections of the separators .

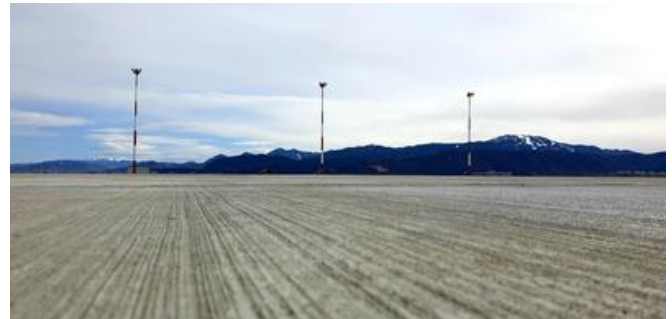
PORR built a high-mast lighting system at the edge of the platform. Source: PORR Construct

The final part of the work was to install the lighting system: three 28m light masts. Each mast has four LEDs, a control panel and a lightning conductor. The foundation is 2.4m high and includes all necessary cables and ducts. It is made of class C30/37 reinforced concrete.
