GROUNDWORK FOR A NEW AIRPORT

Brasov International Airport

PORR is building a runway, an apron and a comprehensive drainage network for Transylvania's new airport in Brasov.

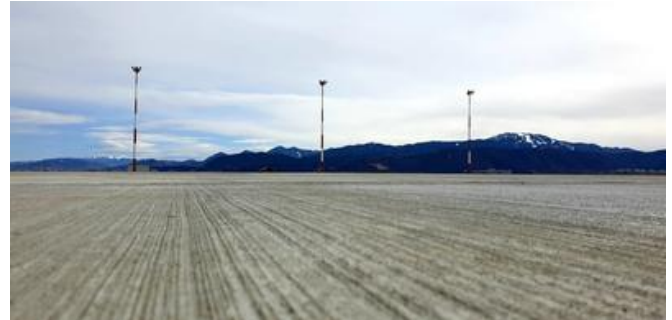
PORR built a high-mast lighting system at the edge of the platform. Source: PORR Construct

The final part of the work was to install the lighting system: three 28m light masts. Each mast has four LEDs, a control panel and a lightning conductor. The foundation is 2.4m high and includes all necessary cables and ducts. It is made of class C30/37 reinforced concrete.
