## GROUNDWORK FOR A NEW AIRPORT

### Brasov International Airport

**PORR is building a runway, an apron and a comprehensive drainage network for Transylvania's new airport in Brasov.**

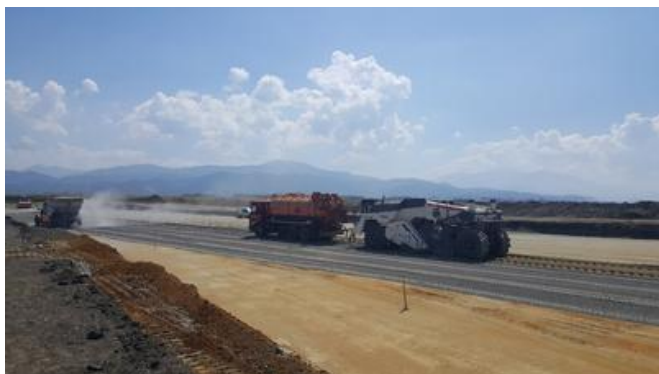
A 25cm thick stabilised ballast layer was laid on top of the lower ballast layer for the taxiway and apron. Source: PORR Construct

The next stage of the structural work for the apron and taxiway was to create a 40cm thick ballast base course. A further 25cm thick course of stabilised ballast was then laid on top of this. Cable ducts were incorporated into the stabilised ballast, so that the power supply cables for the taxiway lights could be laid in the ground. The shoulder was constructed from a base course consisting of 35cm thick ballast beneath a 25cm course of stabilised ballast.

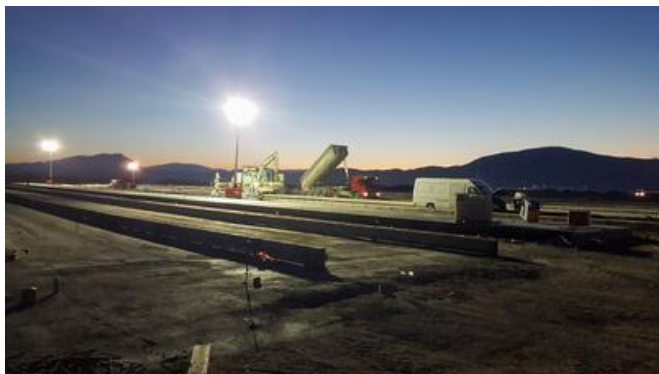
Solid steel girders were used as formwork for the concrete layer. Source: PORR Construct

Solid steel girders were used as formwork for the concrete layer. The project was particularly challenging due to the short construction period, which meant that work had to be done around the clock, including weekends.

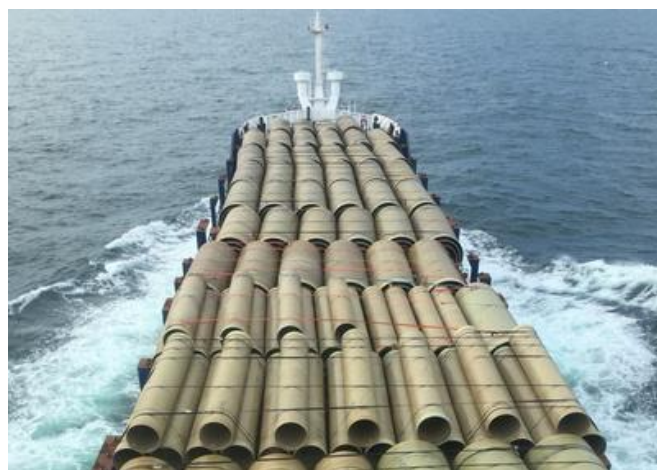
The pipes for the rainwater draining system were delivered from Turkey on two ships. Source: PORR Construct

In just two months, 12km of GRP pipes (DN 500-DN 2000) were manufactured in Turkey and delivered to Romania for the rainwater drainage channels. They were transported to Constanta by two ships and then transferred onto a total of 223 lorries. The first transport had to include every type of pipe, so that work could begin immediately. This was made possible by the collaboration with the excellent delivery contractor APS, who was also responsible for delivering the GRP manholes and concrete manholes.

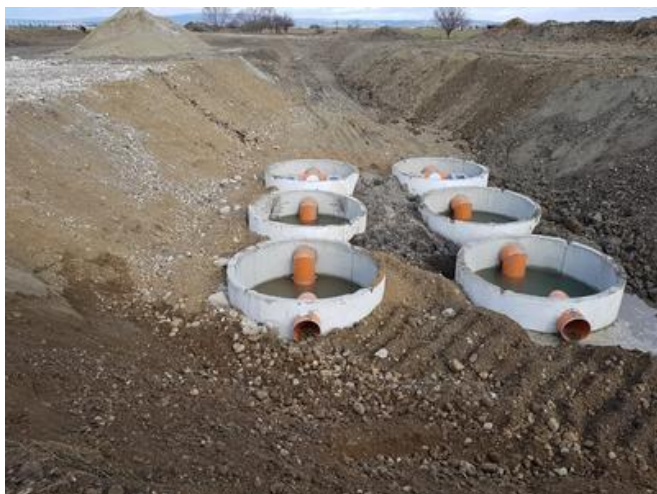
Water is cleaned in the two-stage oil separator system. Source: PORR Construct

The water collected in the drainage network is transported through the GRP pipes to two oil separators that remove impurities from the water. Each separator has a capacity of 440l/sec and there is also a bypass with a capacity of 1,200l/sec.

Installing the oil separators was a significant challenge due to the high groundwater level: we hit water after just one metre of excavation and had to pump it away continuously. A 15cm ballast layer was installed after the required depth was reached. A concrete course, also 15cm thick, followed. Once the separators were in place, the filling began with layers of 20cm thickness of soil, reaching the top sections of the separators.

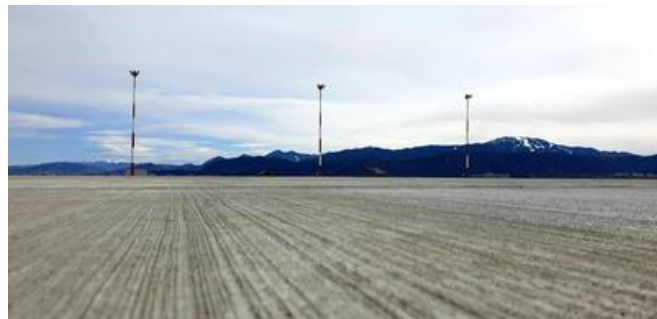
PORR built a high-mast lighting system at the edge of the platform. Source: PORR Construct

The final part of the work was to install the lighting system: three 28m light masts. Each mast has four LEDs, a control panel and a lightning conductor. The foundation is 2.4m high and includes all necessary cables and ducts. It is made of class C30/37 reinforced concrete.
