COMPLETED
ROMANIA/BUCHAREST

READY FOR TAKE-OFF

08L-26R Runway Henri Coanda Airport Bucharest

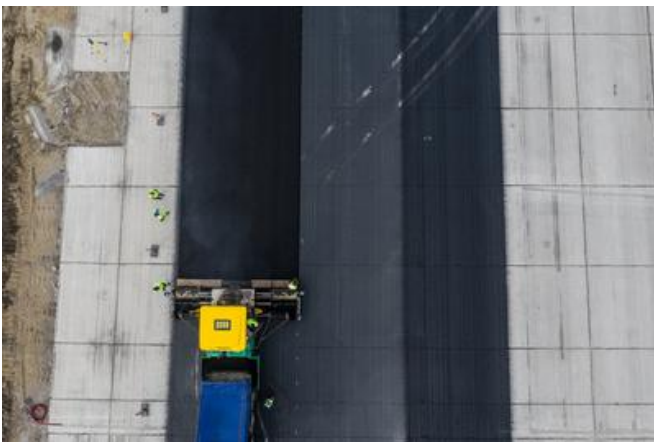
Asphalt paving works on the 45 m-wide runway. Source: PORR

The runway pavement has been computed in accordance with the client's requirements and the applicable norms and standards. The 45 m-wide runway comes with a cross profile of 1.3 %, 7.5 m shoulders and a 2.5 % slope. The additional asphalt reinforcement layers (>15 cm) ensured a Pavement Classification Number, PCN for short, of 92 R/D/W/T.

The rehabilitation works of the runway consisted of the milling of the existing asphalt (28,600 m²) and concrete layers (46,900 m²) on a variable depth, replacing damaged concrete slabs (6,500 m³), recalibration and filling of joints (115,000 m) along with the laying of asphalt mixtures (117,000 t) and markings (16,000 m²) in order to resume the runway functionality.

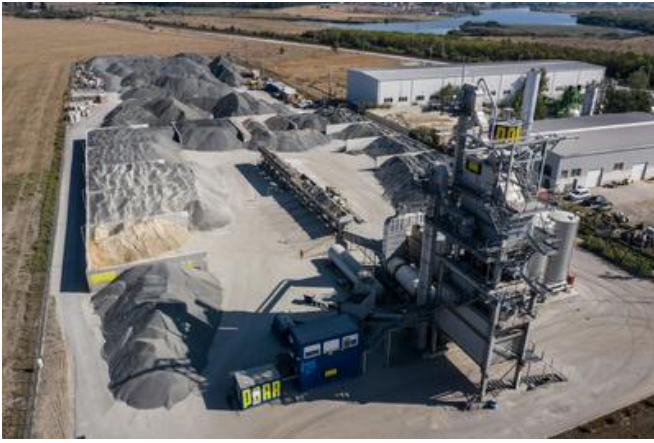
PORR's in-house asphalt plant in Bucharest produced most of the asphalt needed for the runway project. Source: PORR

Most of the asphalt was supplied by PORR's in-house asphalt plant situated in the north of Bucharest. The delivery of such large quantities of asphalt in such a short period of time, marked a huge success for the plant.

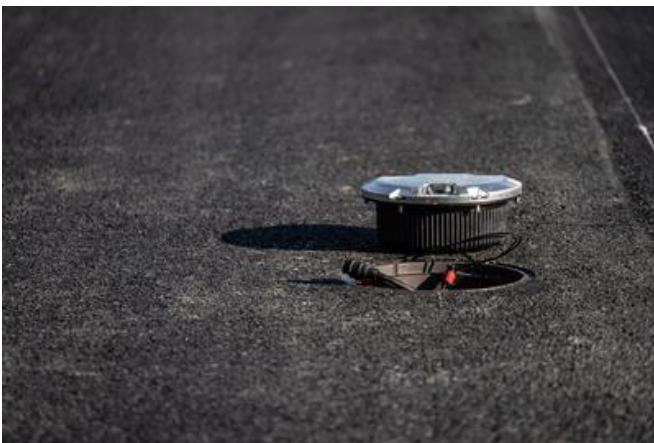
PORR replaced all beaconing lamps on the runway. Source: PORR

The visual aids system for navigation was designed and executed to comply with all regulations for a category III Precision Approach Runway in both directions. The team replaced all the primary and secondary circuits mounted in protection pipes, the aeronautical beacons for the runway threshold, end, centre and touchdown area, the approach system, the stop bar along with all signs and markings. In addition, the tower remote control has been upgraded.

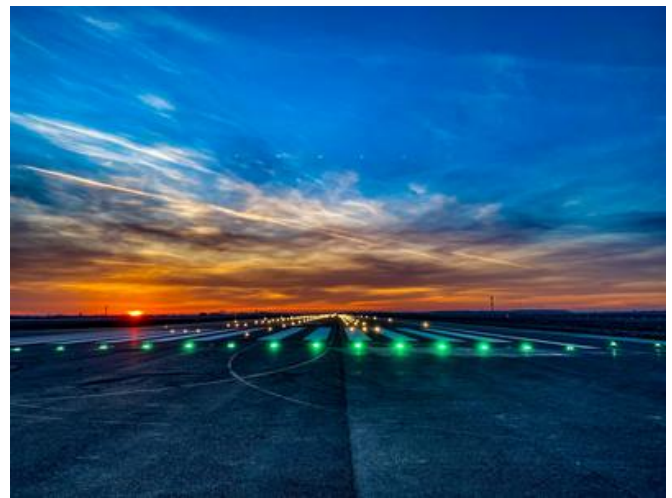
The newly installed beacons illuminate the finished runway. Source: PORR
