SAFETY FIRST

Gas Connect Austria operations building

Following a gas explosion in December 2017, PORR built a new operations building for the Baumgarten gas hub within a remarkably short time.

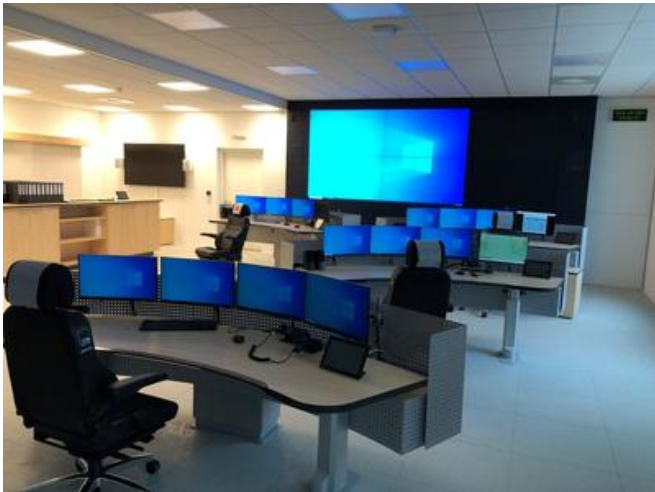
The operations control room is built on an earthquake-resistant raised floor. Source: PORR

In order to make room for the cables that would be needed, the raised floor was elevated by 1m and constructed to be earthquake-resistant. This process required 4-5m high reinforced concrete walls to be concreted in situ in the carcass.

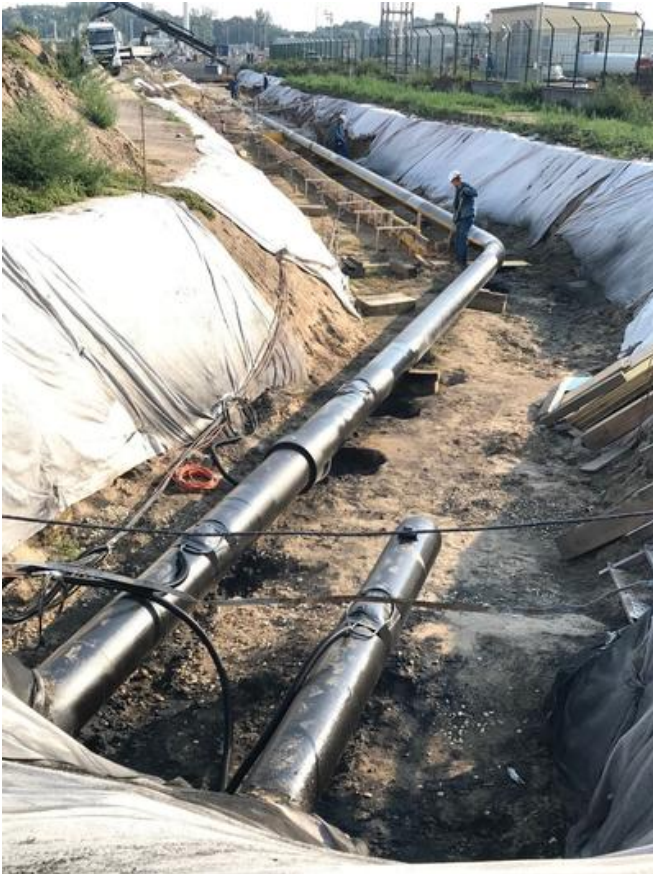
The damaged pipeline had to be excavated along a length of 140m in preparation for replacement. Source: PORR

In parallel with the operations building being constructed, the tendering process was being held for the gas pipeline damaged in the explosion. PORR was also awarded this contract. The pipeline had to be exposed along a length of 140m while under full pressure.

Numerous embedments such as electric cables and ducts added to the complexity of the work, and a lot of the excavation had to be carried out manually.

Once the pipeline had been exposed, the gas was evacuated and the pipeline was replaced, backfilled with sand and the trench filled in.
