PROGRESS: 100% - COMPLETED
AUSTRIA/2017-19

REHABILITATION FOR CHILDREN AND YOUNG PEOPLE

Kokon rehab centre

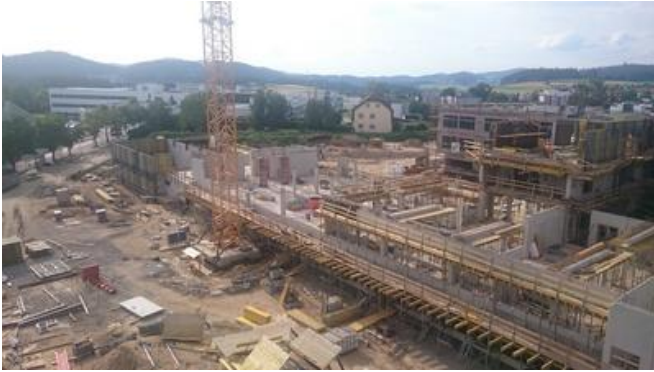
The mixture of rocky ground and loam entailed developing custom solutions. Source: PORR

The consortium built the rehab centre on an undeveloped site. The first construction phase involved removing the hummus and starting excavation. This was followed by installation of the sewage channels and utilities. At this stage the consortium faced its first major challenge, in the form of the tricky ground conditions: rocky, very stable Mühlviertel granite alongside unstable loam. This meant that while in some places the team were chipping away the rock, in other areas a special foundation was being made from grouted ductile piles. The special foundation work was carried out by PORR's foundation engineering department.

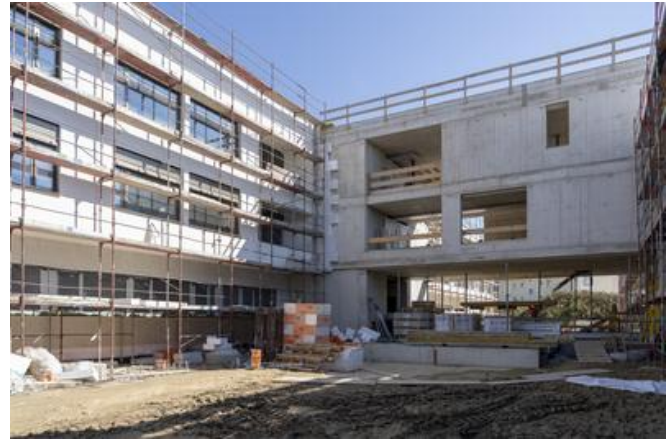
For maximum efficiency, parallel teams worked on the north and south tract on staggered construction stages. Source: PORR

The building has two storeys above the ground floor and two below. The underground levels, which extend to a depth of 9m, were built using in-situ concrete, while the consortium used pre-cast elements and composite construction for the above ground structures. A total of 5,900m³ of concrete and 600 tonnes of reinforcement went into the building.

To achieve maximum efficiency, work continued in parallel, but staggered, on both tracts throughout the construction phase. While the structural work was still in progress in the southern tract, the structural work in the north had been completed and the northern team started on sealing the roofs and installing the windows and facade for the building envelope.
