FIRST-CLASS RENOVATION

Sylvenstein Reservoir headrace tunnel

In Bavaria's Isar Valley, PORR carried out badly needed renovations on the Sylvenstein Reservoir headrace tunnel.

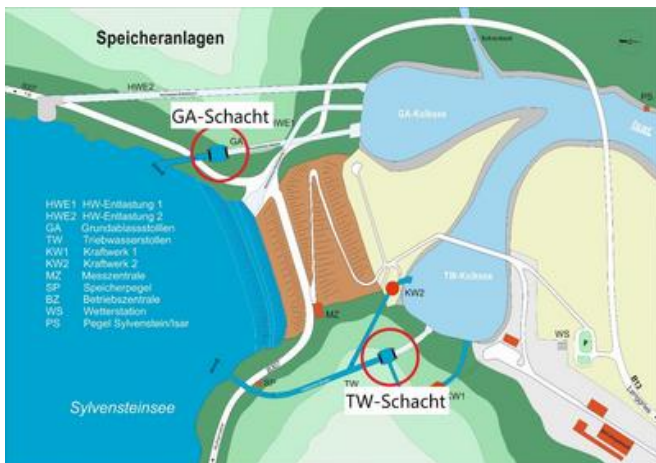
Overview plan of the Sylvenstein Reservoir, showing the sluice tunnel in the north and the headrace tunnel in the south. Source: Wasserwirtschaftsamt Weilheim

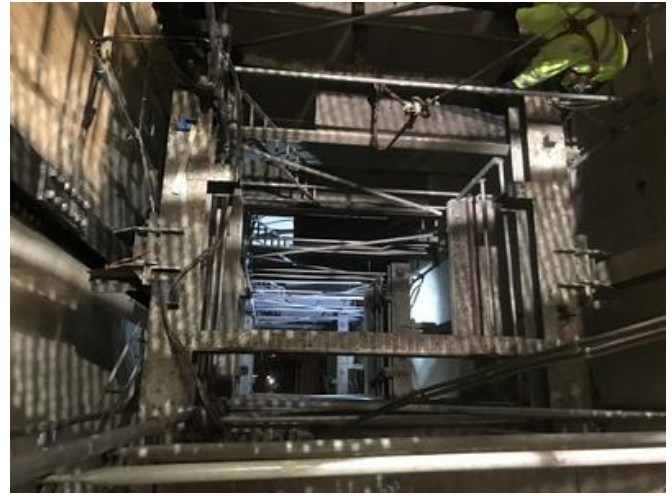
PORR built a 560 m³ interior scaffold for safe removal of the steel parts. Source: PORR

According to the renovation plans, the existing 8m-wide, 42m-deep wet shaft was to remain in place. However, the top and bottom sluice gates and their drive mechanisms were to be replaced. The team began by removing all the steel parts that were no longer needed. The sluice gates, 4.5m high and 2.8m wide and weighing some 36 tonnes, were moved using electromechanical winches. These were positioned in a cavern that was only accessible via a steep and narrow – just 3m wide – route blasted into the rock. The bottom sluice gate was removed first – this was a two-part roller sluice gate with a hydraulic drive unit installed in the centre. About 560m³ of interior scaffolding, plus a gantry with a 45m-long electric chain hoist, were installed for the dismantling and demolition work. The equipment was used to lift out the steel parts, slice them up and transport them away for stripping. Once the new bottom sluice gate had been manufactured and installed with the hydraulic steel construction, work began on demolition of the top sluice gate.

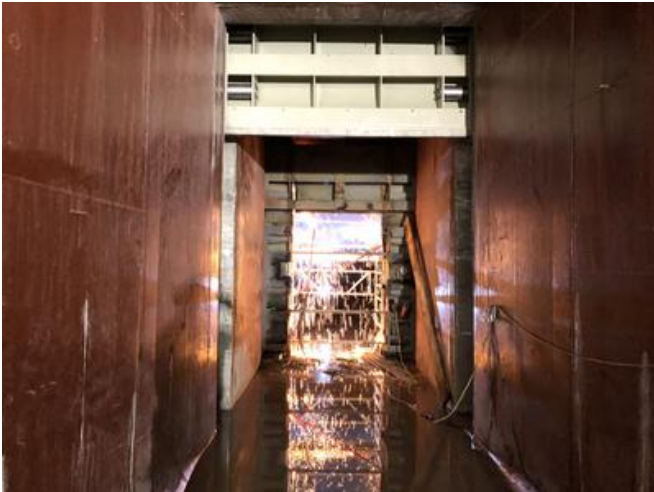
The PORR team worked under stringent safety measures as they painstakingly removed the 36t sluice gates piece by piece. Source: PORR

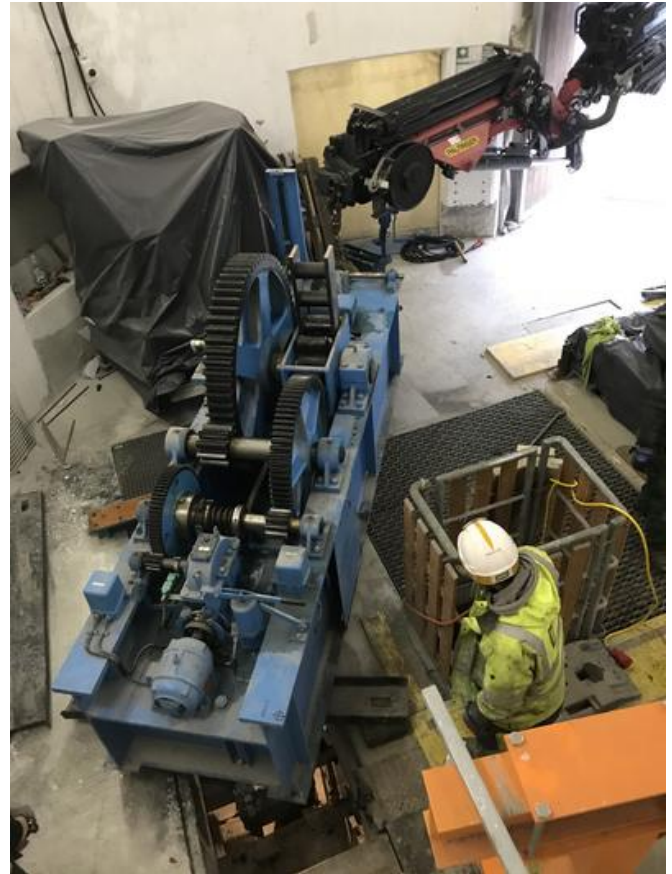
The winch mechanism for the top sluice gate was dismantled in the cavern. Source: PORR

The next milestone was dismantling the winches on which the lifting rods (and on these, the sluice gates) were mounted. The objective was to remove the winches without damage, overhaul them, and then store them properly until they could be returned to the employer for display on the Sylvenstein Reservoir site.

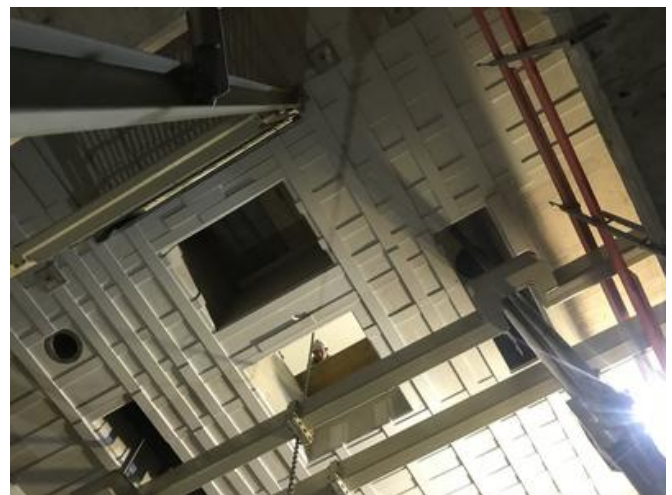
The cavern floor was structurally reinforced with CFRP fins. Source: PORR

One major challenge PORR faced was concreting the cavern floor. Due to tricky structural conditions, the concreting had to be done in a number of stages. To ensure characteristics suitable for the structural loads, approximately 2,300kg (\approx 260m) of CFRP fins had to be glued into crosses on the underneath of the cavern floor and anchored in place.

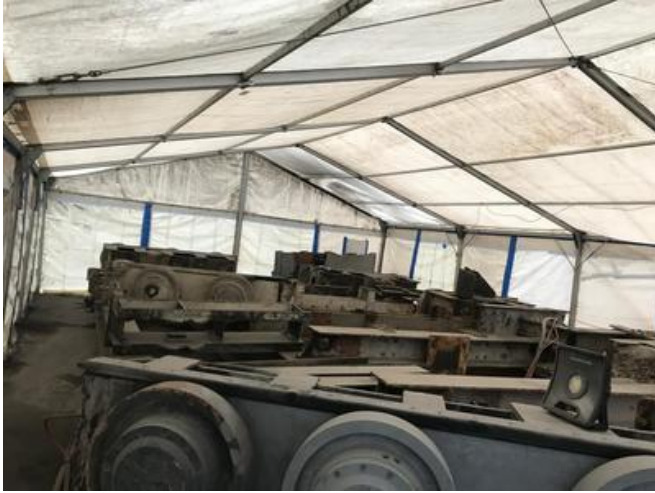
The team worked in a dust-tight treatment tent to strip the steel parts. Source: PORR

The teams coordinated with PORR Umwelttechnik for the task of stripping the old asbestos paint from the removed steel parts on the construction site and preparing them for subsequent disposal. A total of 29t of asbestos-contaminated grit and 65t of steel were professionally treated and disposed of.
