**PROGRESS: 100% - COMPLETED**  
AUSTRIA/TRAUNSEE/2017-18

## TURNKEY TRAINING CAMPUS

### Traunkirchen Forestry Training Centre

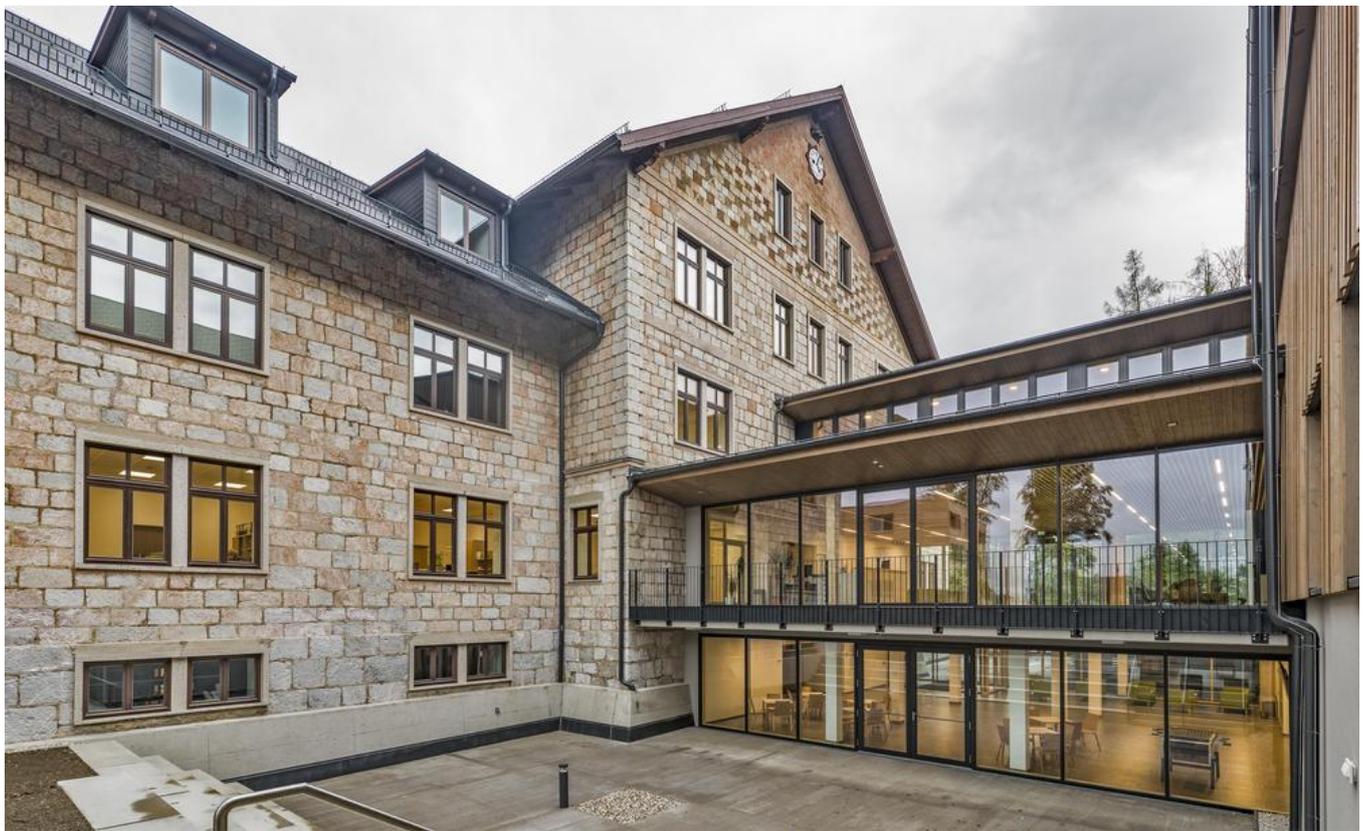
Glazed walkways link the heritage-listed hunting lodge to the newly-built school and residential buildings. Source: Gerd Kressl

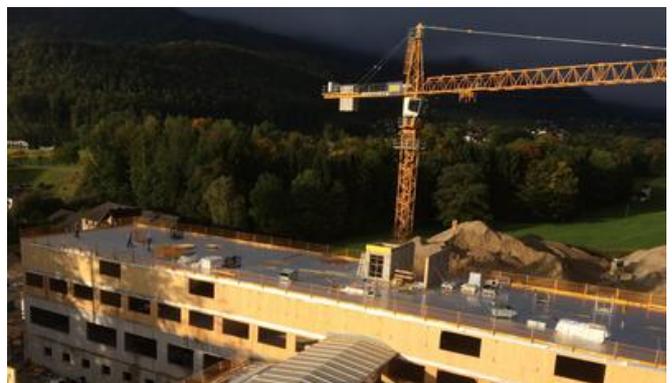
Construction progress at the new training centre on Lake Traunsee in October 2017. Source: Gerd Kressl

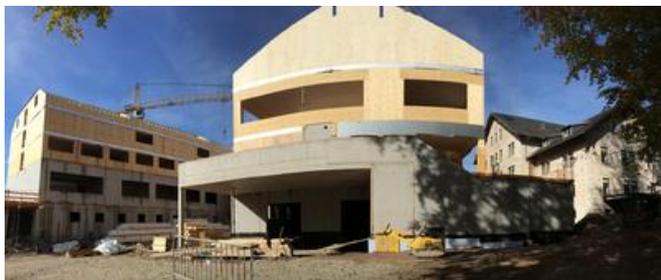
Two weeks later: work begins on the roof truss. Source: Gerd Kressl

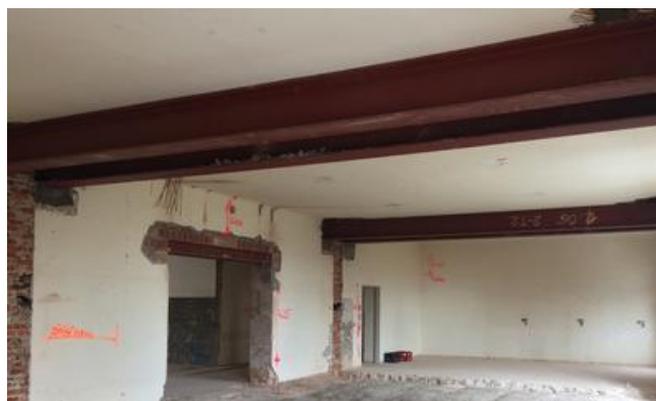
Internal supporting walls had to be removed from the large dining hall and the ceilings underpinned with steel beams. Source: PORR

An unpleasant surprise met the PORR workers when they exposed the old wooden ceilings: various damages meant compliance with the relevant norms was impossible.

Additional timber had to be incorporated into all the ceilings. In addition, all the gaps in the original Traunstein marble facade had to be supplemented with original material, and the facade restored to its original condition; a clock on one of the gables also needed renovation, and in addition to the above-ground work, all the drainage systems and underground pipes in the cellar were brought up to date. All covered components were fitted with fresh seals and perimeter insulation. An old arch, exposed during the renovation work, is now a feature in the newly-built bistro. Internal supporting walls on the second floor had to be removed and the ceilings underpinned with steel beams before the large dining hall could be created as required. An external emergency stairwell was built on the north side, as specified by the authorities.

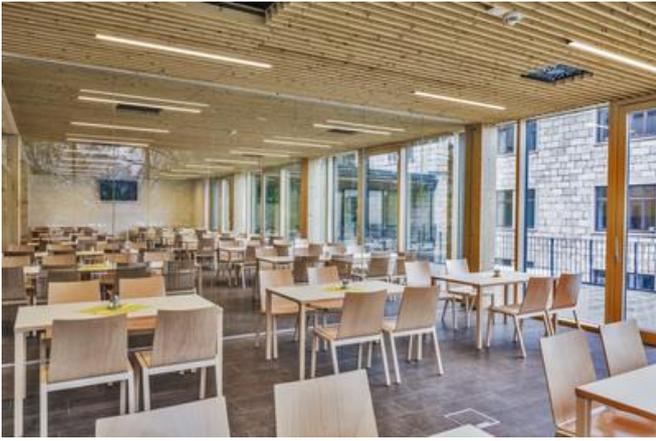
Timber is the main construction material used in the canteen. Source: Gerd Kressl

As a forestry training centre, the new training campus aims to stress sustainability. Consequently, timber had an important role to play as a construction material. Both the school and residential blocks were largely built based on timber structures. Where fire protection permitted, wood was also used for the walls and surfaces. Sample tests of the wooden facade and its rear ventilation were carried out at a 1:1 scale on site, inspected and approved by the architect. The wooden facade and windows have been optimised for insulation quality. The roof areas are being used to generate solar electricity. Heat is supplied from a biomass power station. The multipurpose hall and server rooms are cooled by means of heat density cooling together with the use of a spring located on the grounds. In the spirit of the klimaaktiv building standard, electric vehicle charging points have also been installed, along with bicycle stands.

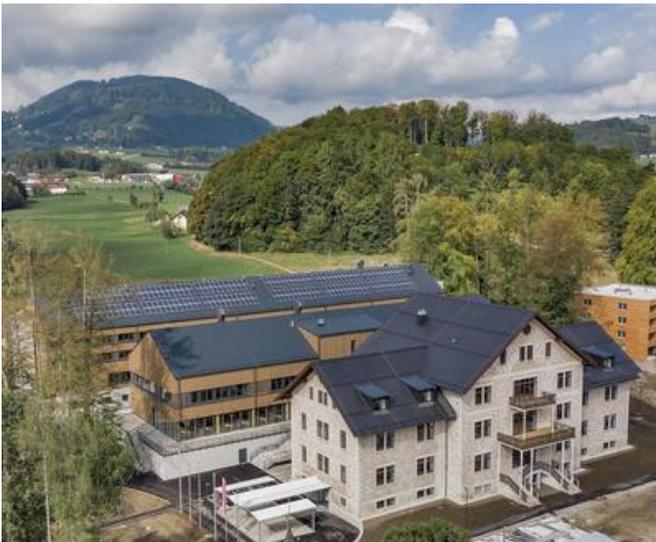
The original building is in the foreground; behind it can be seen the new timber buildings with solar panels on the roof. Source: Gerd Kressl

The innovative and thermally high-quality building envelope, coupled with state-of-the-art efficient building technology and the 123 kWp solar system, represents an important foundation element for the klimaaktiv “Gold” certificate. PDE supported this aspect of the project from the initial contract award through to the inauguration of the Centre. Initiatives such as building project management and optimisation of the energy technology across the entire project meant that PORR could act as a “one-stop shop” to meet all the customer’s requirements. The subsequent quality assurance was carried out via various measurements, e.g. airtightness in the spaces, quality of the air inside and sound insulation. Great collaboration between the construction site and PDE ensured that the klimaaktiv Gold Standard was achieved without significant additional effort for the contractor or extra costs for the client.
